Home Condition Survey

Date: 05-Mar-2016

Surveyor: Mr Neil Maudsley

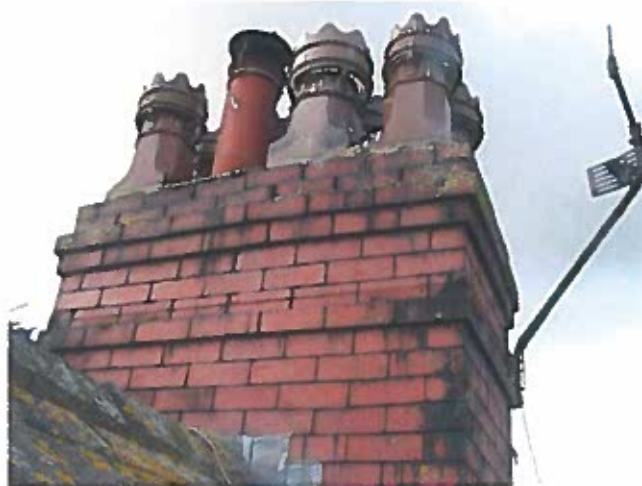
CHIMNEY.JPG

Description and Justification for Rating and any comments	Condition Rating
D1. Chimneys and flues	<p>The chimney stack is brick built and is shared with the neighbouring property to the left.</p> <p>Lead flashings are in place providing a waterproof joint between the chimney stack and the roof covering.</p> <p>There are 4no chimney pots to the top of the chimneys serving the chimney breasts/flues.</p> <p>The TV aerial is securely fixed.</p> <p>Some areas of mortar pointing have eroded/are missing.</p> <p>The flaunching at the top of the chimney stack is cracked.</p> <p>1no chimney pot is cracked.</p> <p>There are missing terminals to 3no chimney pot leaving the chimney/flues open and vulnerable to rain penetration/dampness/blockage by birds.</p> <p>The top section to the side of the chimney is bulging outwards.</p> <p>This is considered serious and in need of urgent repair or replacement.</p>	3

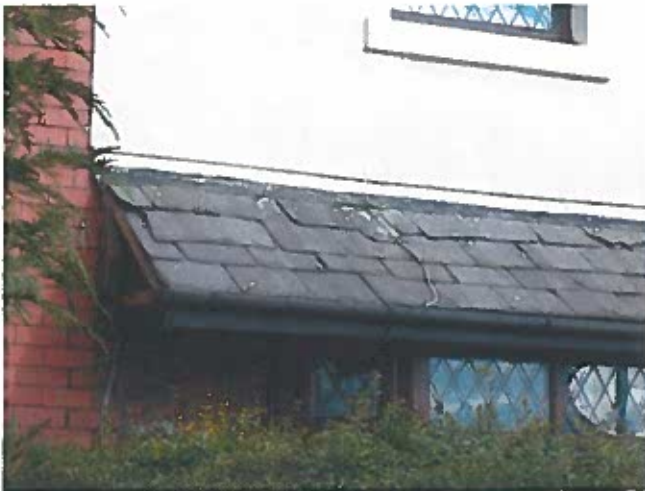
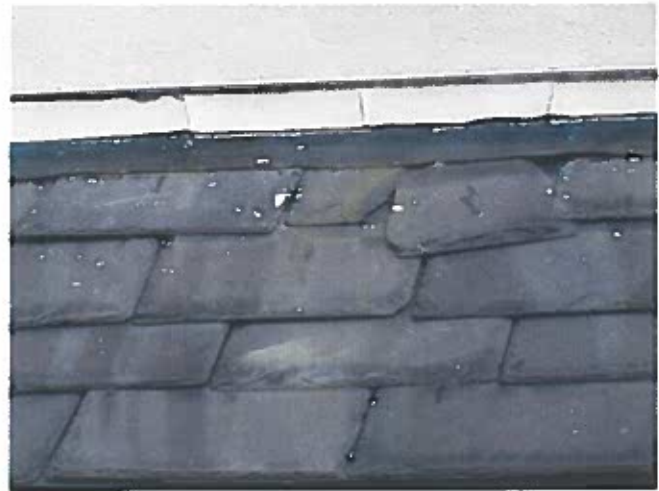
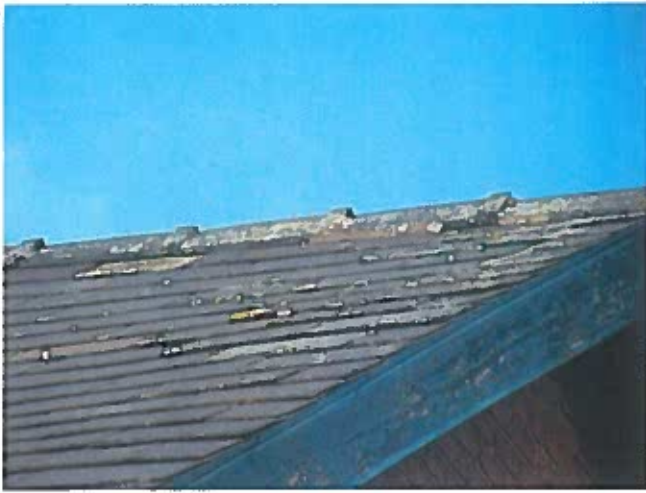
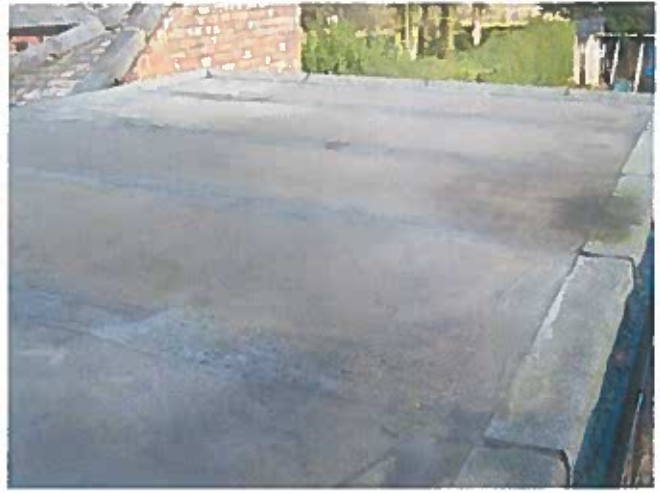
Some areas of slating to the front bay/canopy roof are loose/have slipped/are cracked/are poorly secured/have temporary repairs.

The main roof has been repaired using a number of metal clips (lead tingles). There is no evidence of an extensive problem such as nail fatigue or "nail sickness" at present but the need for repairs will increase until the covering is renewed.

The mortar bedding/pointing to the ridge tiles is loose/is missing generally in places.

Some repairs or replacements are required but these are not considered serious or urgent.

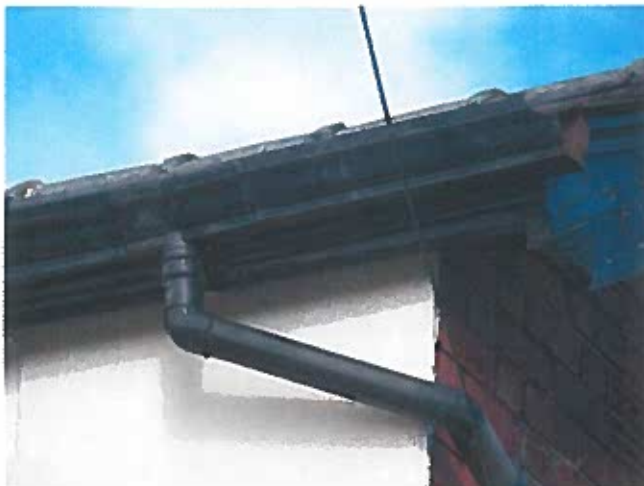
GUTTERS.JPG

The gutters (cast-iron) to the front elevation are generally showing signs of leakage/rusting/corrosion.

The gutters to the front bay/canopy are leaking.

The gutters are generally showing signs of leakage.

These defects could lead to water penetration/dampness problems internally if not rectified.

This is considered serious and in need of urgent repair or replacement.

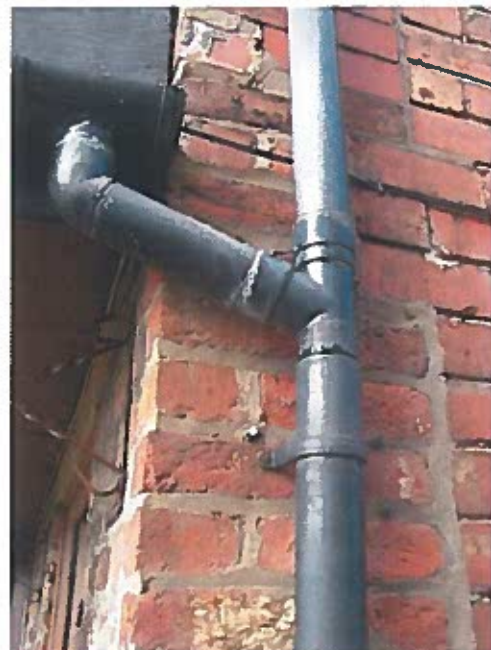
RWP.JPG

The RWP to the front elevation is loose/not securely fixed.

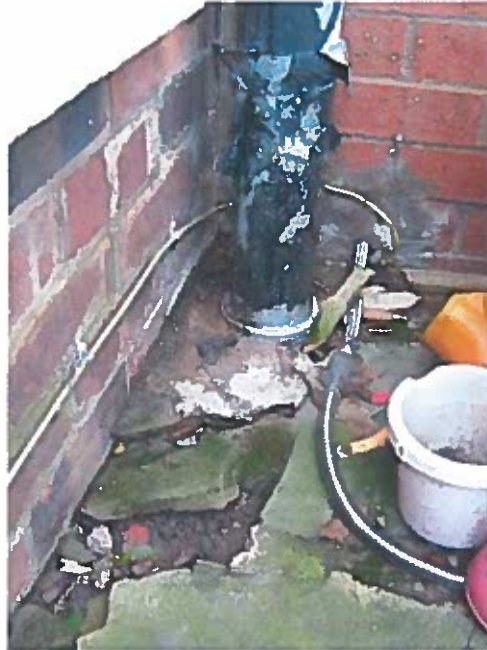
SOIL PIPE.JPG

The joints to the soil pipe are leaking and have been temporarily repaired.

The soil pipe is loose/not securely fixed.

The bird cage/terminal on the top of the soil pipe is missing leaving the soil pipe vulnerable to blockage.

This is considered serious and in need of urgent repair or replacement.

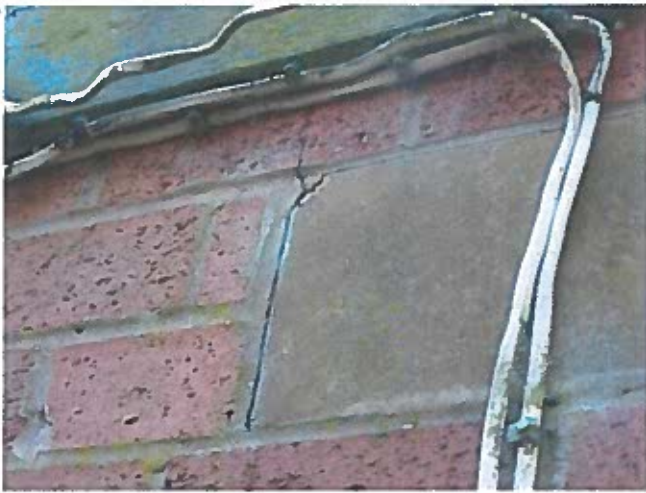
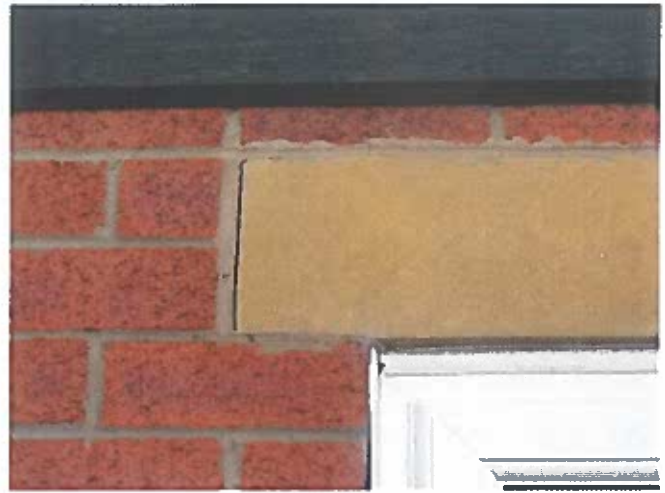
There is evidence of structural cracking to the window openings. This is ongoing requiring further investigation. For more information please see (Section D/Section E).

There is cracking to the masonry above the windows externally to the rear kitchen extension. This could be attributed to issues such as initial settlement, thermal movement, corrosion of existing lintels and disturbance by previous window and door replacement works.

Without carrying out further investigation (outside the scope of the Home Condition Survey service) however, I was unable to determine the actual cause of the masonry cracking and whether any underlying structural issues exist.

Further investigation is advisable which may entail exposing works.
See Section B: Movement & repair issues.

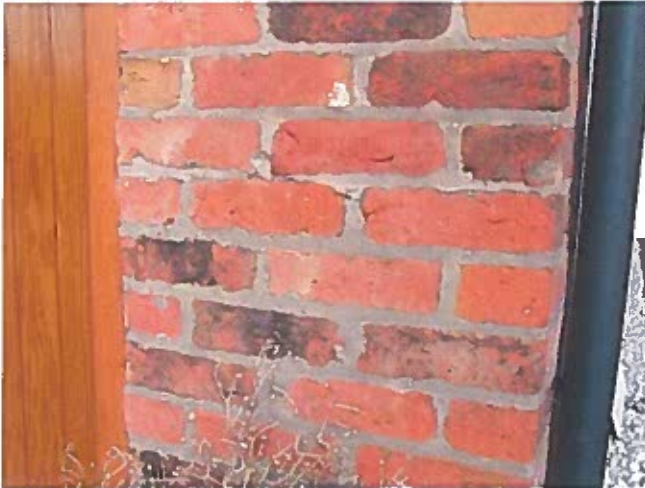
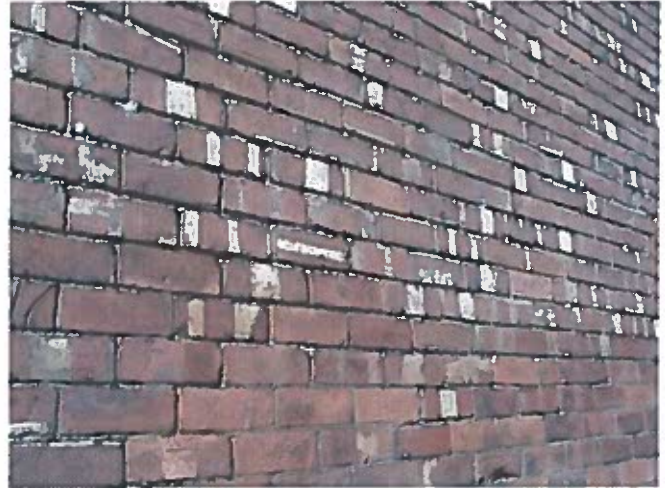
The mortar between the bricks (called the pointing) to the main gable & rear elevations has eroded in places. This could cause penetrating dampness problems internally if remedial works are not carried out (re-pointing).

This is considered serious and in need of urgent repair or replacement.

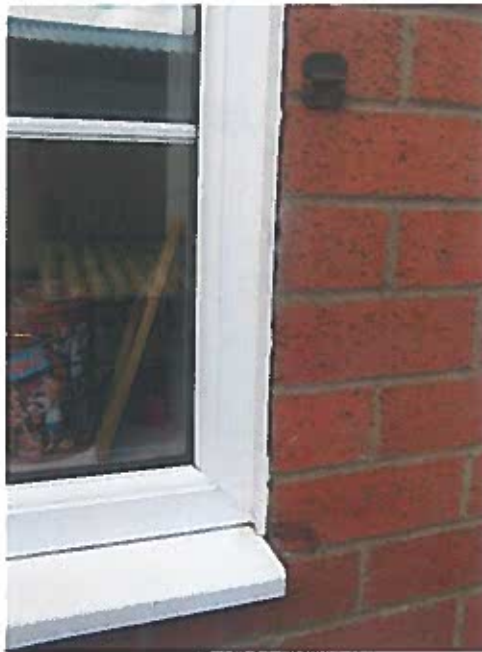
WINDOWS.JPG

External sealants to the kitchen extension window frames are cracked/loose/missing.

Lack of adequate sealants around window frames can cause rainwater to penetrate internally causing dampness issues if not rectified.

Some repairs or replacements are required but these are not considered serious or urgent.

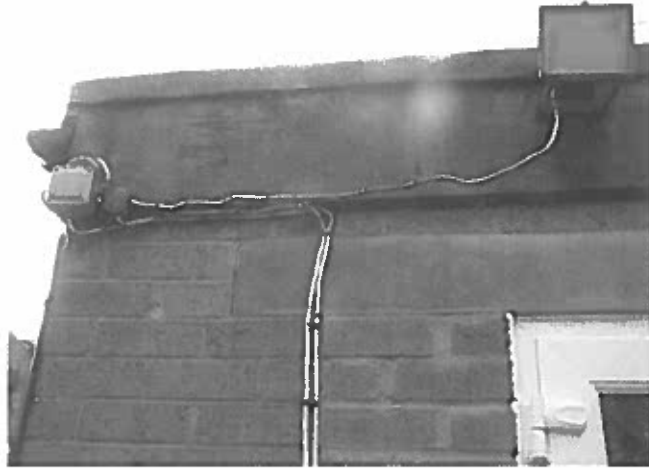
EXT WOODWORK.JPG

The fascia boarding to the rear extension roof is showing signs of wood rot and in need of repair/replacement.

Some repairs or replacements are required but these are not considered serious or urgent.

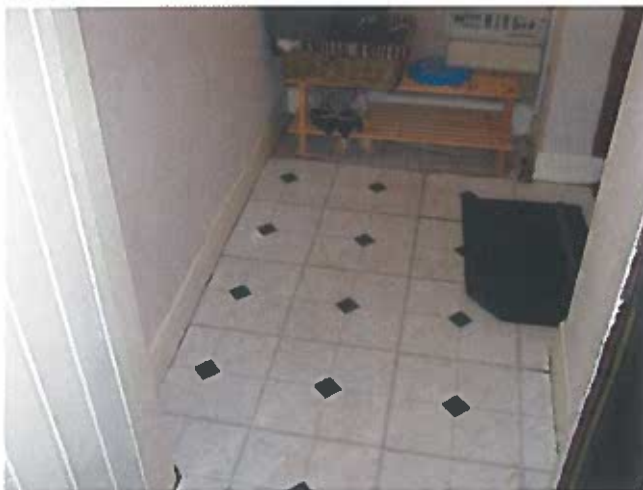
DAMPNESS.JPG

Higher than normal damp/moisture readings were noted at low level to the inside surface of the front/gable elevation in the hallway and the skirting boards are rotten.

Without carrying out further investigation (outside the scope of the Home Condition Survey service) I was unable to determine the cause of the dampness however it may be possible the DPC has failed in this area.

It is recommended this isolated area of dampness is investigated further by an appropriately qualified professional (remedial treatment specialist).

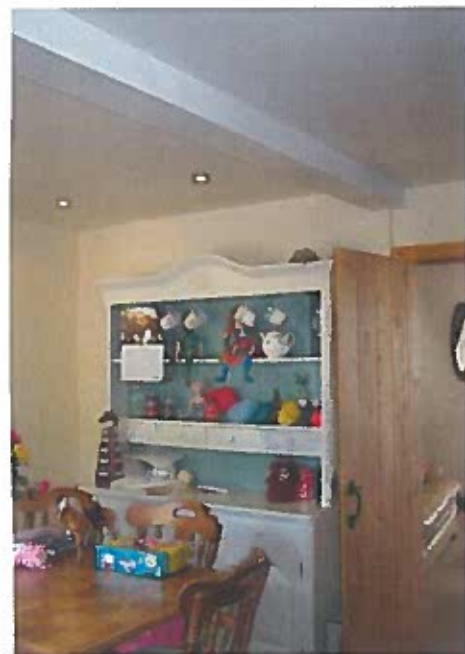
INT ALTERATIONS.JPG

There is evidence of the removal of internal walls (dining room) to the inside of the property which is likely to represent a risk to the structural integrity of the property. Further investigation is not recommended.

There is evidence of internal alterations relating to the removal of an internal wall to the rear dining room. It would appear the upper floor/walls above are supported by a beam. However, there was no evidence of movement/cracking to suggest the presence of structural movement. This work may have required Statutory Consent (Building Regulation approval).

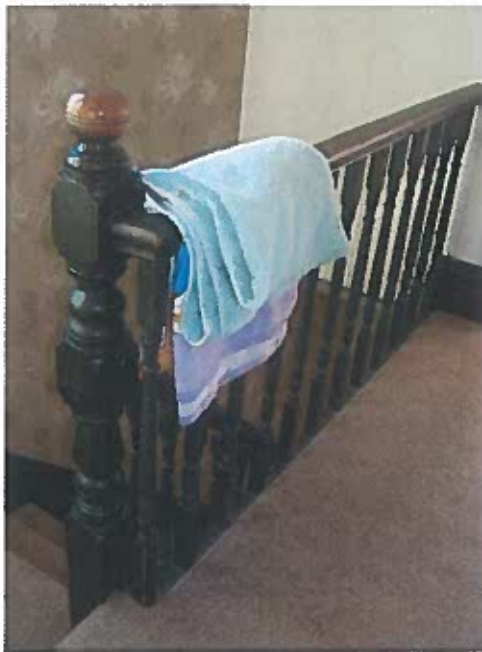
BALLUSTRADE.JPG

The balustrade/newel post is loose to the landing area and should be secured.

The stair treads to the bottom of the staircase are loose/bouncy underfoot.

Without further investigation outside the scope of the Home Condition survey, however, I was unable to determine the actual cause of this defect. Further investigation is required to determine the cause of this defect which may involve invasive inspection.

This is considered serious and in need of urgent repair or replacement.

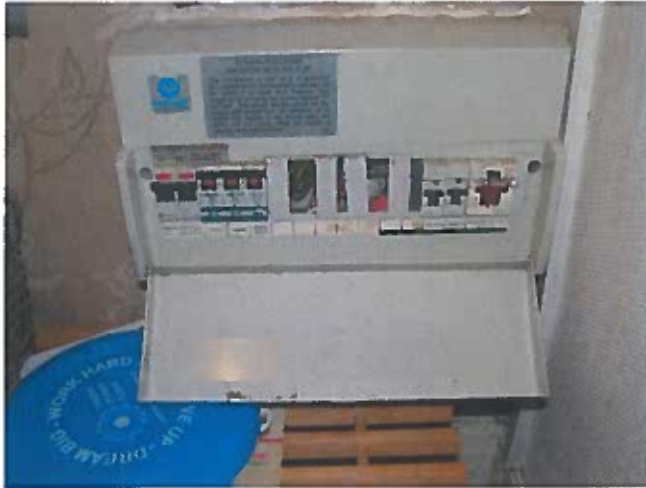
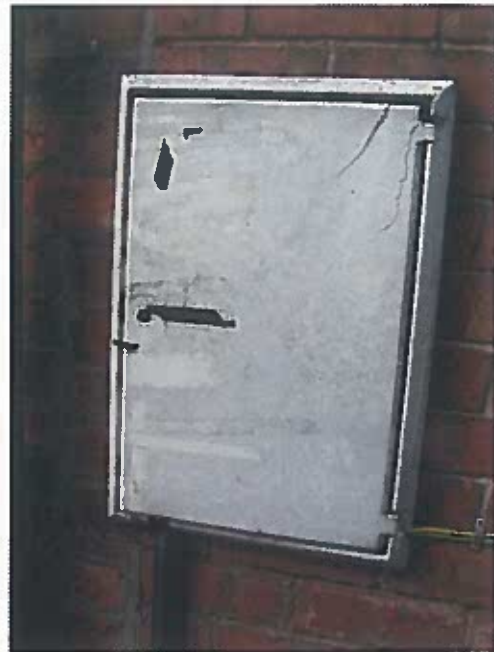
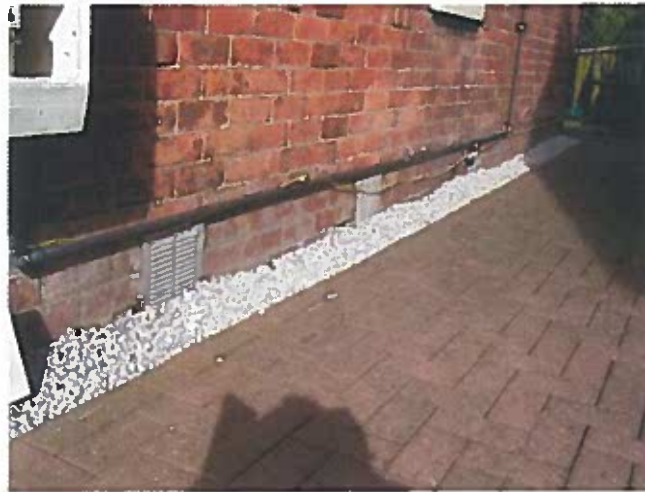
F1. Electricity	Normal maintenance must be undertaken. The main earth bonding cable to the gas meter is exposed externally and may not comply with current regulations.	
Electricity (health & safety)	The electrical system may not be covered by a current inspection & testing certificate. This is a potential safety hazard. See Section C: Health & Safety.	3

Further advice should be obtained.

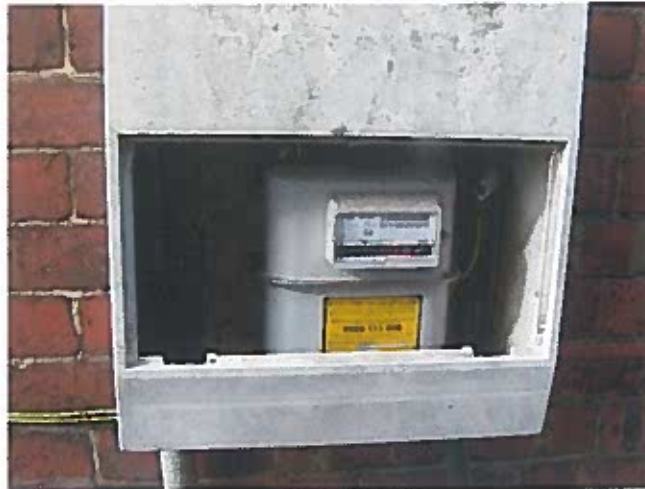
GAS.JPG

This is a potential safety hazard.

Further advice should be obtained.

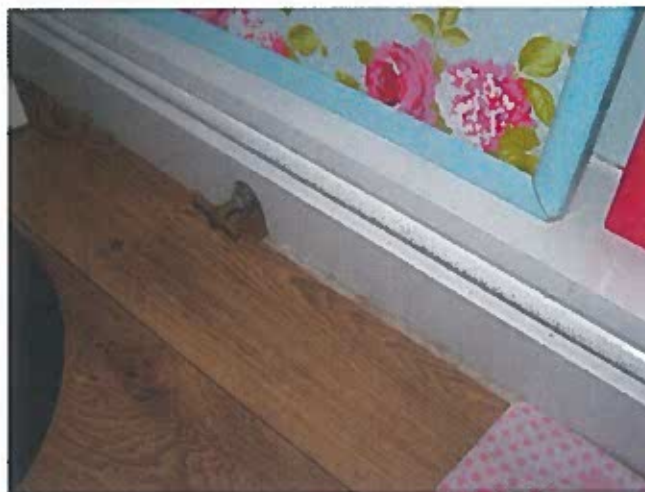
WATER.JPG

It was not possible to inspect the mains water pipe & stop cock as it is concealed behind pipe boxing. It was not possible therefore to determine the type of pipe material (lead/plastic).

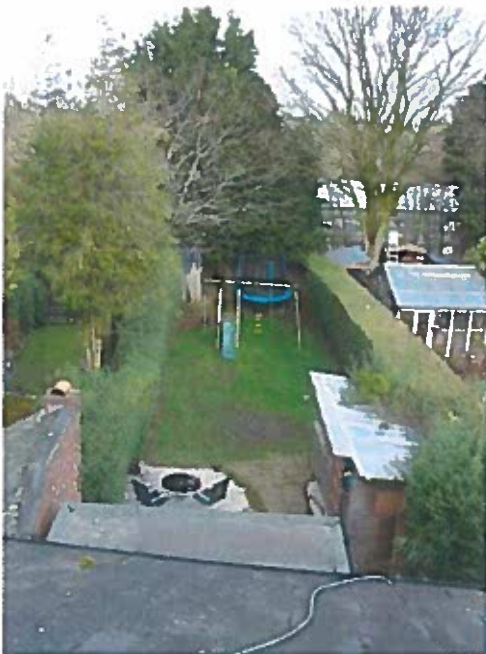
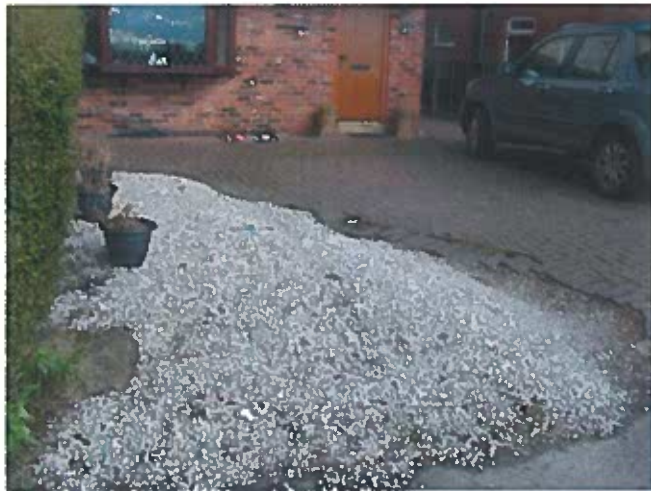
There is a line of Conifer trees along the rear boundary of the property. Although not normally considered a problem in relation to tree root damage, these conifers can grow rapidly. For this reason it is advisable the trees are regularly controlled/trimmed/maintained.

There is a mature tree to the rear neighbours garden. There are no obvious signs of building movement due to tree root damage. The tree is considered to be within an acceptable distance from the property.

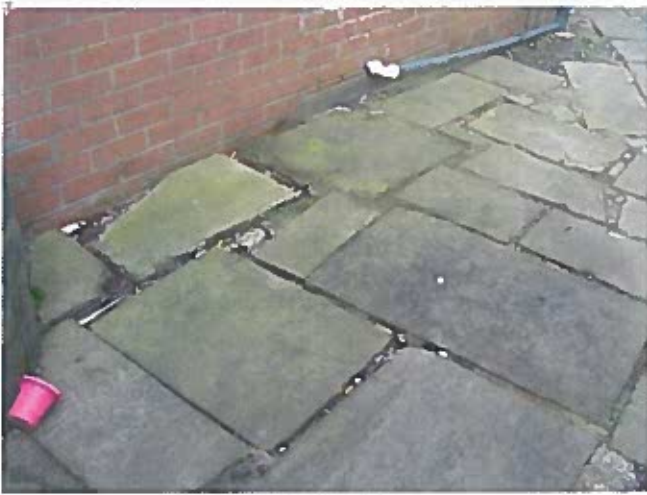
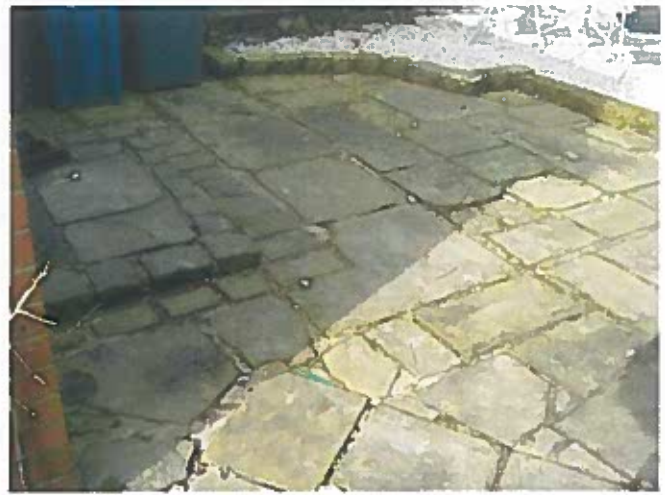
There are areas of loose/uneven/sunken block paving to the driveway which are in need of attention.

There is loose/cracked/sunken paving to the rear of the property in need of attention.
