Home Condition Survey

Date: 12-Nov-2016
Surveyor: Mr Neil Maudsley

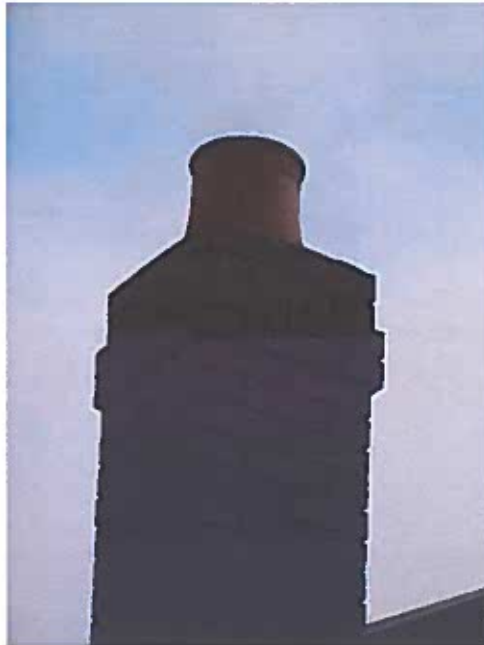
PB120070.JPG

The chimney pot is cracked and is not fitted with a chimney terminal/cowl and is therefore open to the elements/weather. This can result in rainwater penetration causing damp patches within the property and affect internal finishes. It is important to have chimney terminals/cowls installed to open pots to prevent birds/nesting material from becoming trapped within the flue. Blocked flues can cause lethal gasses to build up within the home and therefore this work should be carried out by a HETAS or Gas Safe registered engineer.

3

This is considered serious and in need of urgent repair or replacement.

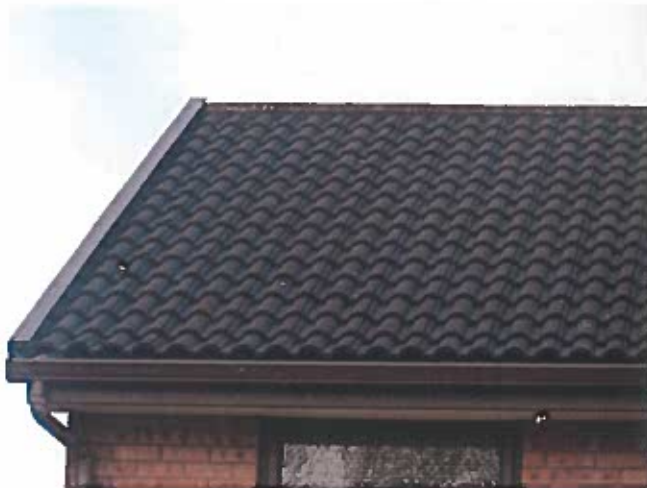
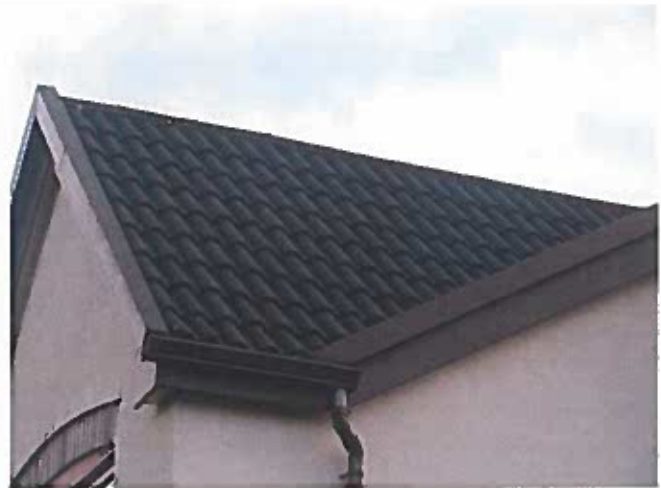
From what can be seen from an external inspection and also following an internal inspection of the dwelling where we were looking for potential roof leaks, no evidence of any defects was apparent.

1

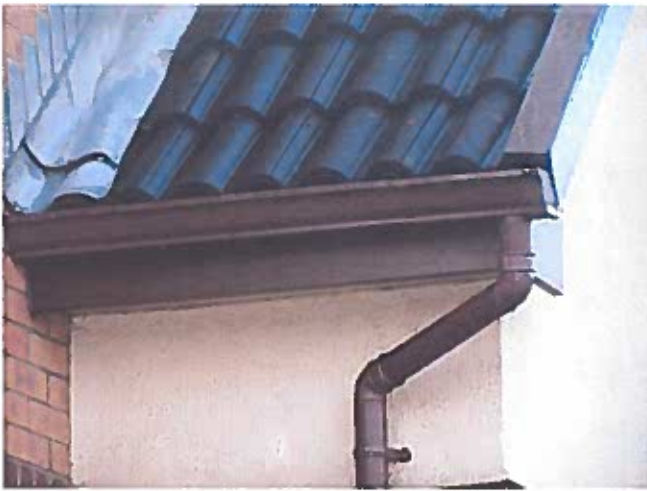
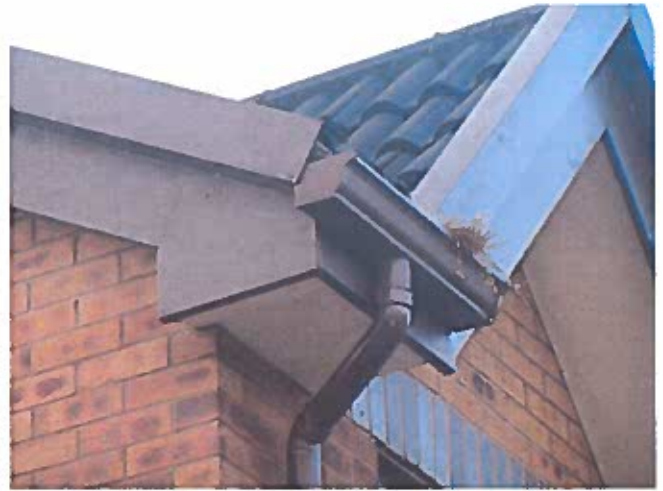
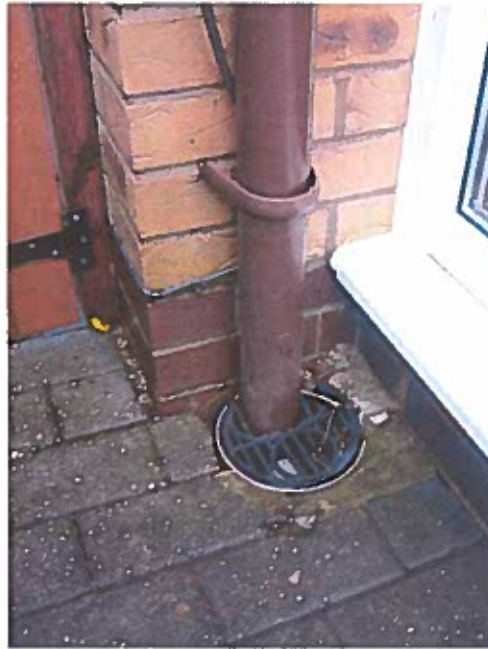
The rainwater pipe to the main rear elevation is loose/not securely fixed (broken clip) and should be re-fixed to maintain the above ground drainage system in a serviceable condition.

The gutters to the front and rear elevations are blocked in places. We would recommend that all the PVC gutters are checked and cleaned out where required. This should also be done periodically to prevent any blockages. It is important to keep rainwater fittings clear and free from leaks to prevent rot to timbers and damage to the fabric of the building. It would be advisable to carry out these checks in due course as part of the general maintenance to the property.

2

Some repairs or replacements are required but these are not considered serious or urgent.

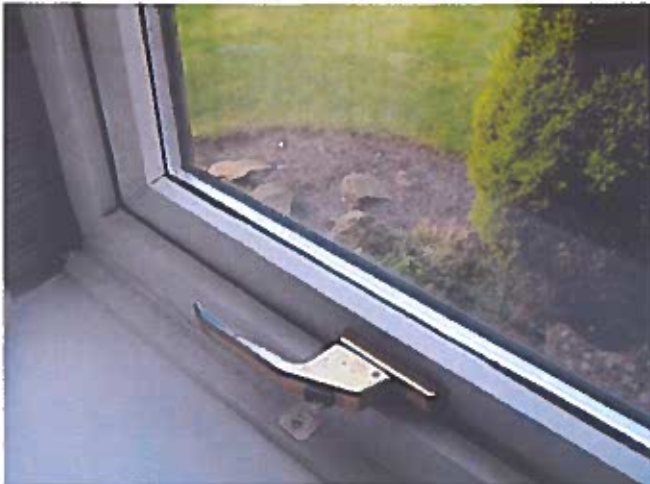
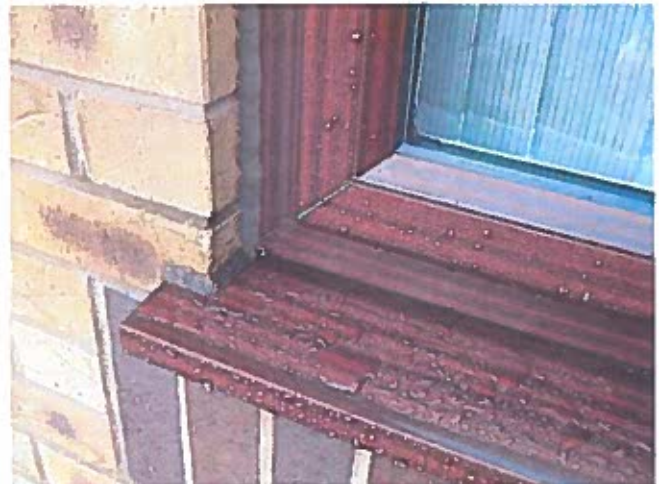
A selection of opening casements to the windows were checked for operation & were found to be generally in a serviceable condition although some wear and tear is evident to window furniture and fittings. External sealants to window frames are in place providing waterproof joints.

No significant defects were observed to the windows.

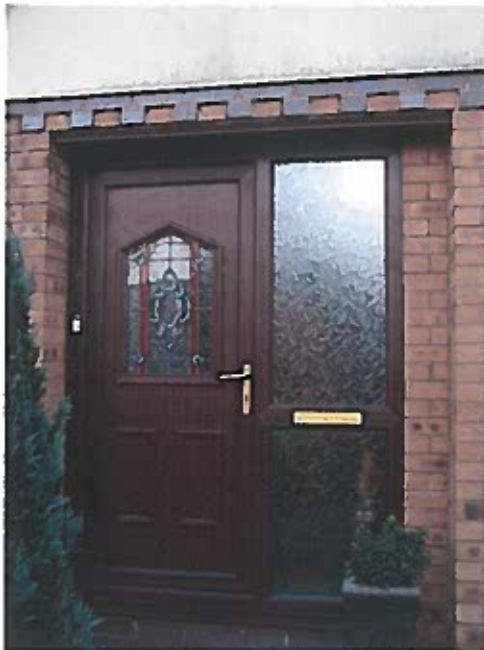
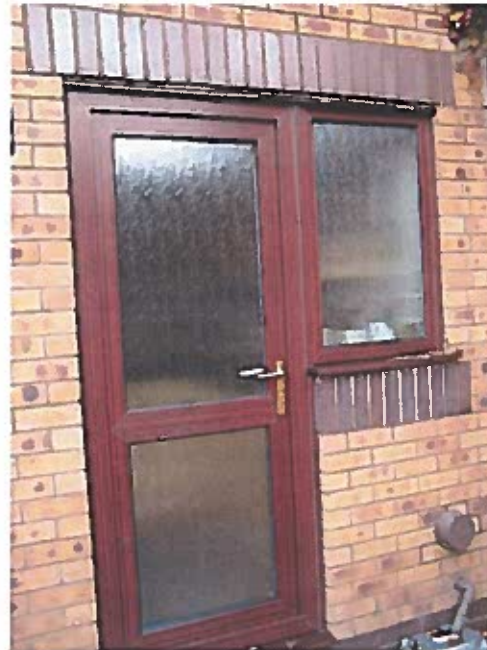
The external doors were tested for serviceability and were found to be in general good working order. The doors are operational and lock correctly. The door frame sealants are in place externally providing a waterproof joint.

1

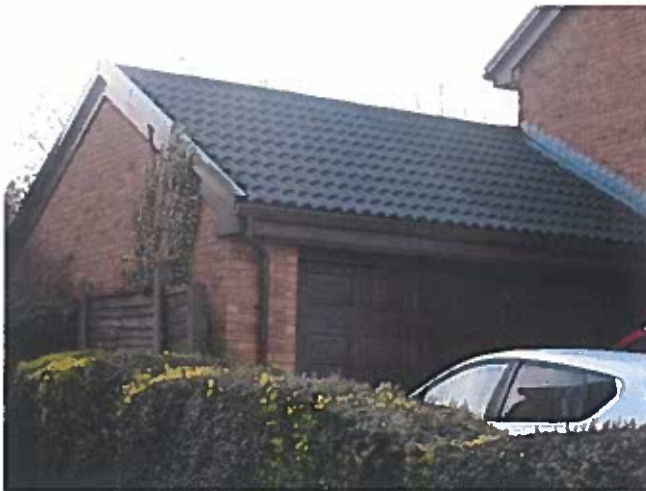
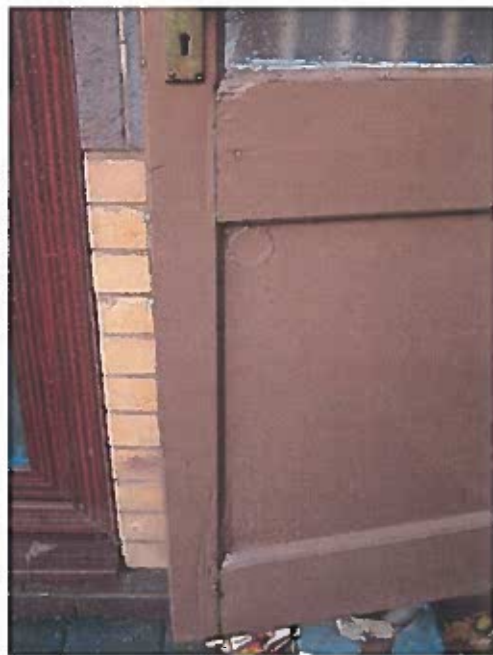
The timber entrance door (single glazed) and door casing to the rear of the garage is rotten and the door casing cill is loose. The door (including casing) casing should be replaced as part of the general repairs/maintenance of the property.

The garage is in a good state of repair but some general maintenance work should be anticipated to maintain the condition of external elements such as fascias/rainwater fittings/external decoration and finishes.

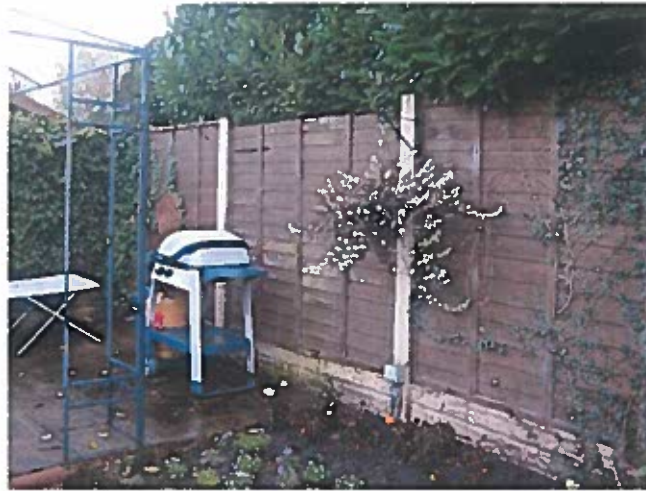
PB120085.JPG

The rear boundary fencing is generally in good condition, however, in places some panels are showing signs of wood rot or are rotten and should be replaced as part of any ongoing maintenance/repairs to the property.
