SAMPLE REPORT 2
LEVEL 2 HOME SURVEY

Detached property

Built 2001

LEVEL 2

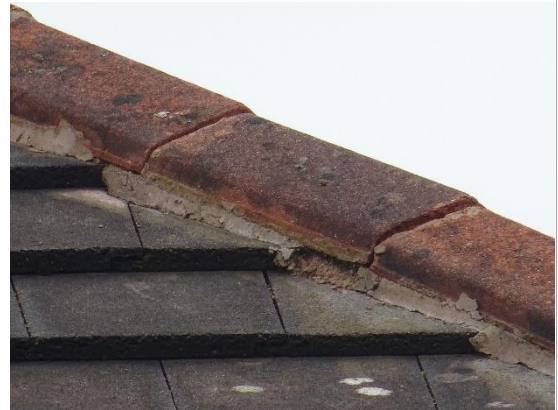
- The mortar pointing to the ridge and hip tiles is missing, cracked and starting to loosen in several areas. The thickness of the bedding mortar is excessive in some areas and is to a very poor finish.
- General cracking and loosening of the mortar to the edge of the front gable valley gutters was observed. The mortar seal to one of the valley gutters is missing/incomplete. The roof structure is therefore exposed in this area and will be a source of water ingress over time if not rectified.
- There are several damaged, slipped and cracked tiles to the main roof.
- The roof underlay could not be fully seen at eaves level and I cannot confirm its condition or whether it properly laps into the guttering. This increases the risk of water ingress at eaves level.

The roofing works have been carried out to a very poor standard overall and the extent of the defects observed suggests the list of works outlined in the invoice may not have been carried out in full. Specifically, the original sarking felt underlay can be seen to be still in place (as viewed from the loft inspection) and it would appear some of the ridge/hip tiles have original mortar pointing.

Ridge tiles

To prevent further deterioration and the risk of water ingress, I recommend that you arrange for an independent assessment to be carried from a reputable roofing contractor to advise you on the scope of works necessary to rectify the defects seen. This may result in completely stripping and retiling the main roof which may be a more cost effective solution than attempting to rectify

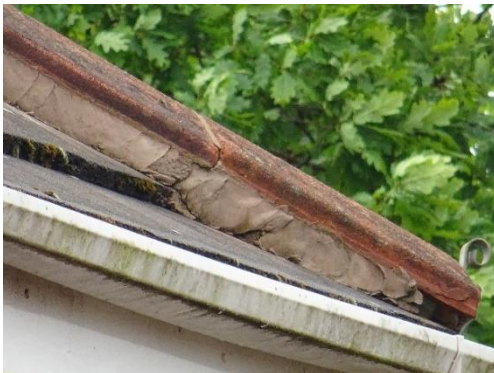
Hip tiles

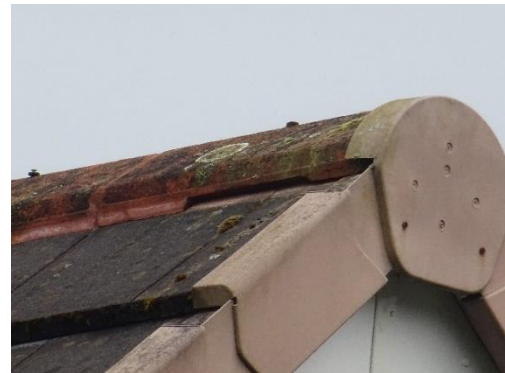
Mortar bedding

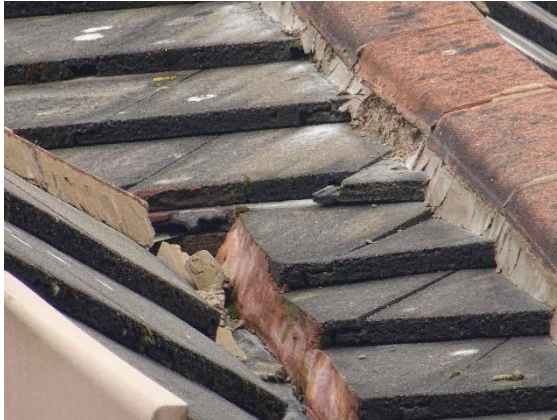
Ridge tiles

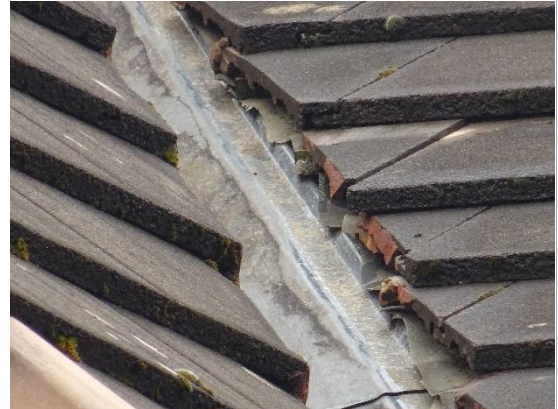
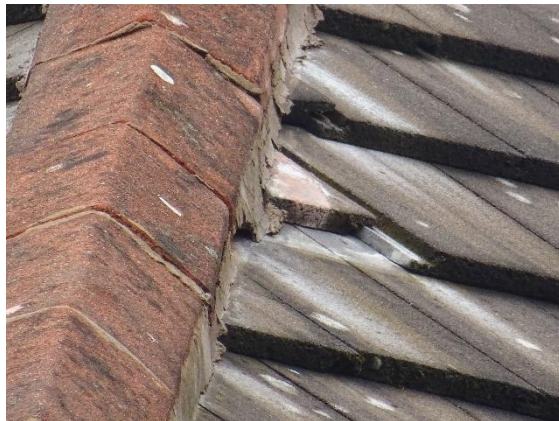
Valley gutters

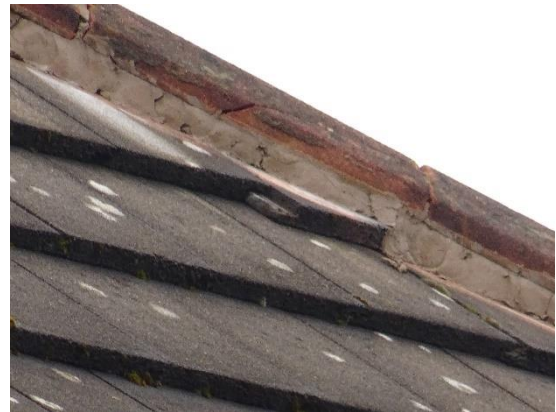
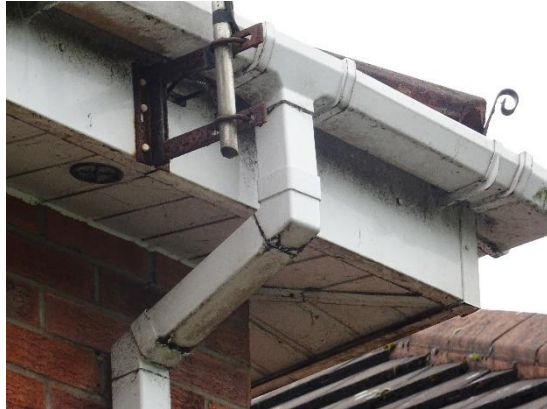
Damaged tiles

- The rainwater pipe joints are stained and leaking in places and should be repaired / resealed.
- There is vegetation growth to the gutters which needs to be cleared to prevent overflowing.
- A section of the guttering to the front elevation is loose and disconnected. This should be re-connected/refitted to reduce the risk of leakages and future defects developing.

Condition Rating 2.

Leaking rainwater pipe joints

As it was not raining at the time of my inspection I am unable to be certain that all of the joints are free from leakage. I recommend the fittings are inspected during wet weather to enable any leakage to be identified and rectified.

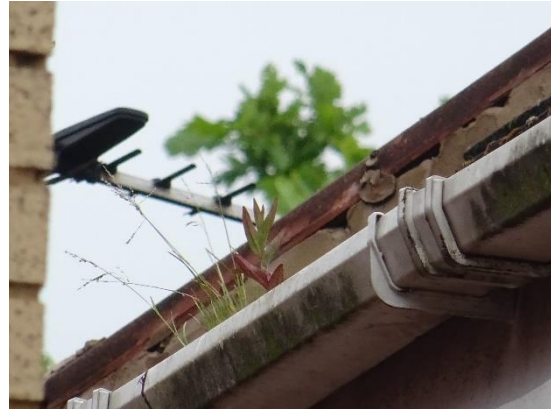
Blocked gutters

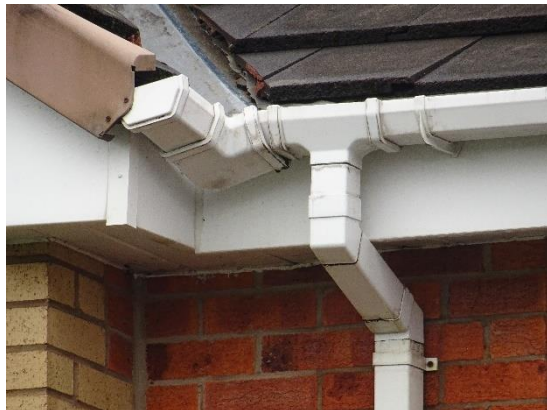
Loose guttering

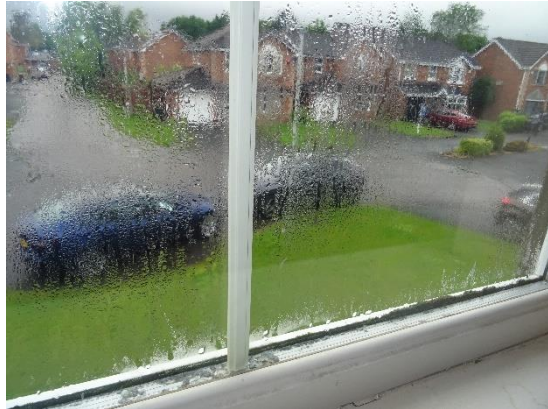
- The glazing in the master bedroom window has misted over due to failure of the seals. This cannot be repaired and the affected panes need re-glazing.
- Gaps were evident to the sealant between the window frames and the surrounding masonry. This needs replacing to reduce the risk of damp penetration.

Condition Rating 2.

Misted/failed double glazing unit

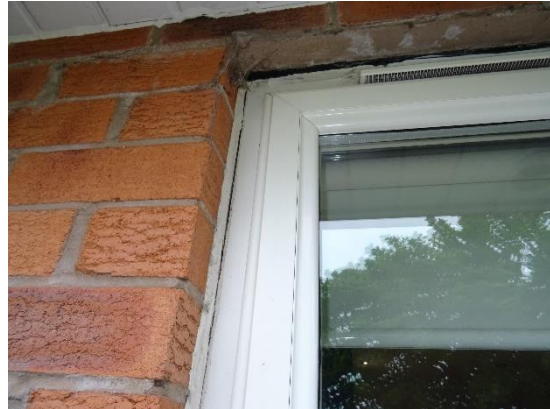
Gaps to frame sealants

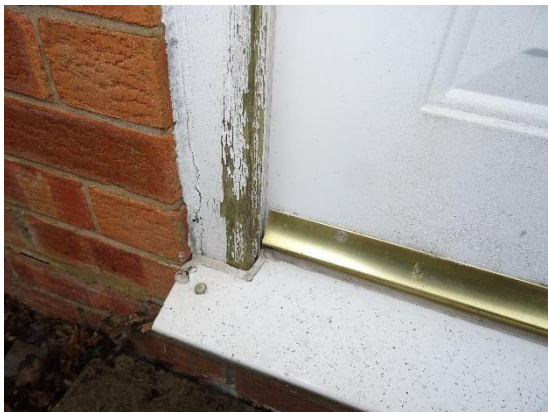
- The external decoration to the timber door casings is showing signs of weathering. This should be re-decorated which should include thorough preparation by removal of all loose and flaking decorative finishes, filling of all cracks and making good any damage prior to priming of bare surfaces and re-application of appropriate decorative coatings.

Weathered paint finishes

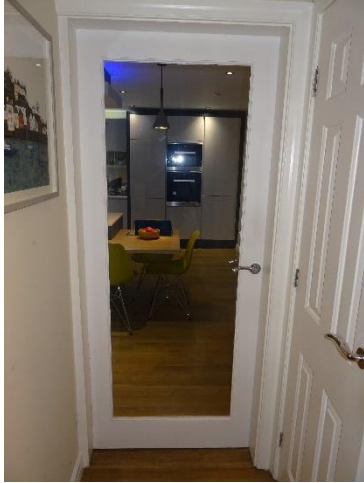
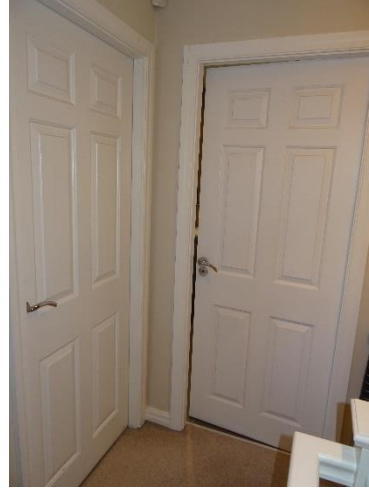
- Some doors are in need of adjustment to allow them to latch fully, prevent binding and to allow ease of operation. The affected doors should be eased, adjusted, refitted and repaired as necessary to ensure they operate effectively.

Condition Rating 2.

Internal doors

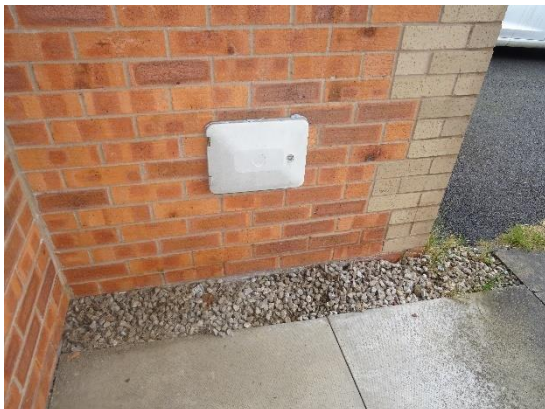
Condition Rating 2.

Damaged/broken meter box

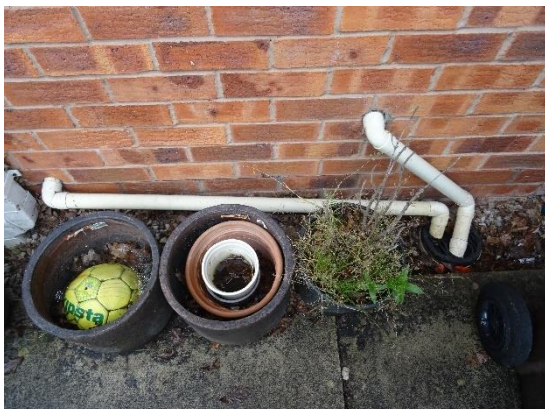
Kitchen waste pipes - loose

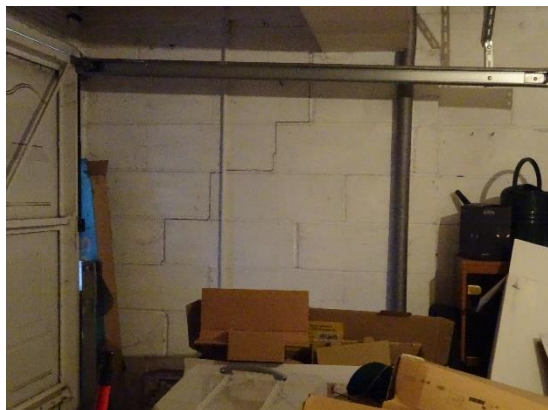
Minor cracking

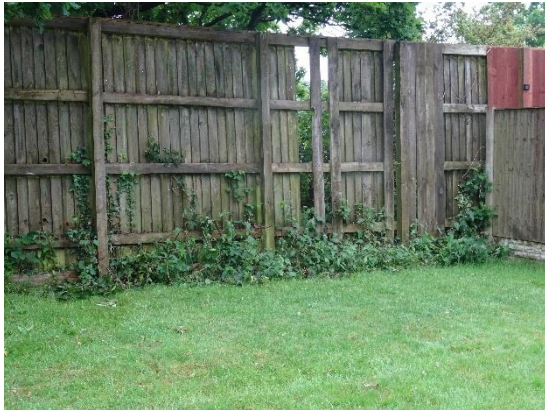
Boundary fencing – repair/replace

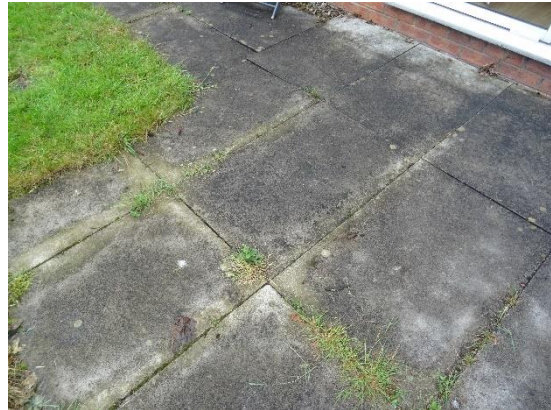
Rear paving – loose/uneven
