SAMPLE REPORT 3

LEVEL 3 HOME SURVEY

Semi-detached property

Built 1935

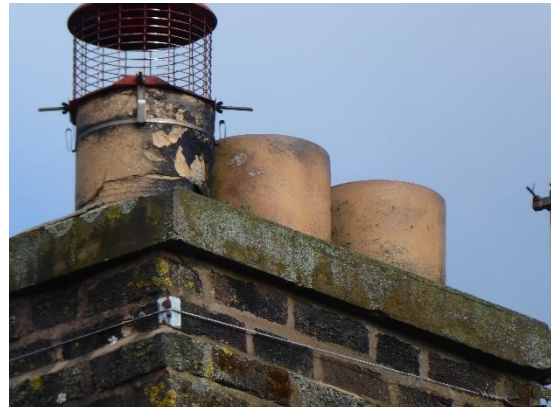
- There is a cracked chimney pot to the left-hand stack. This should be replaced.
- Some of the chimney pots are open and unprotected. This will lead to rain water entering the flues and consequent damp penetration and deterioration internally. Protective rain cowls should be fitted to the pots to reduce the risk of future defects developing. Where flues are no longer in use purpose made ventilated chimney pot caps should be fitted to prevent water ingress and nesting birds.

Condition Rating 3.

Cracked chimney pot/open pots

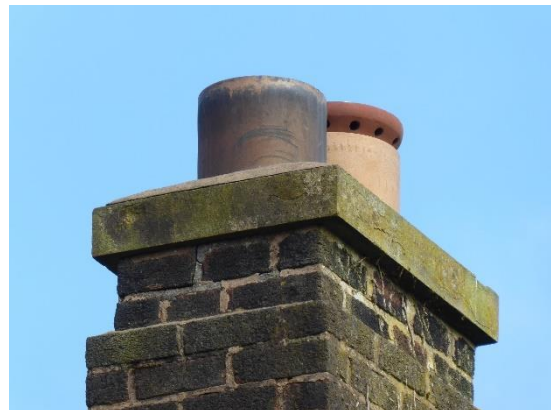
Open pot

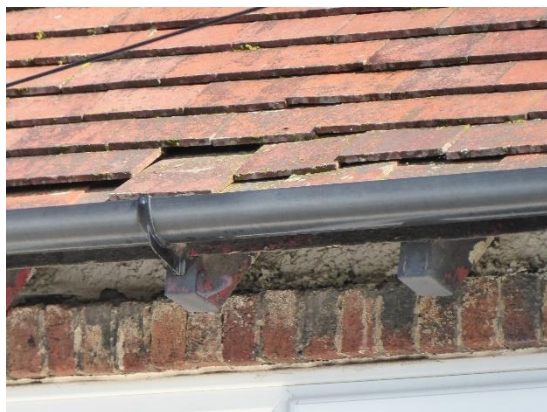
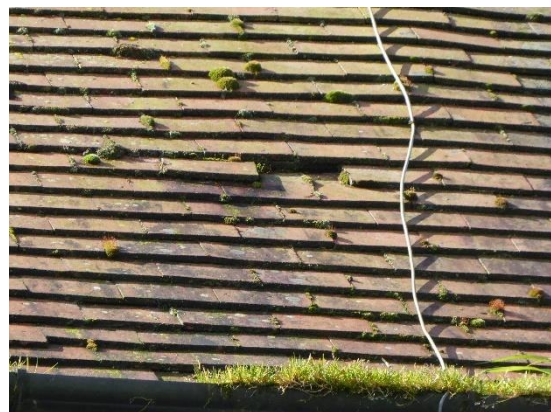
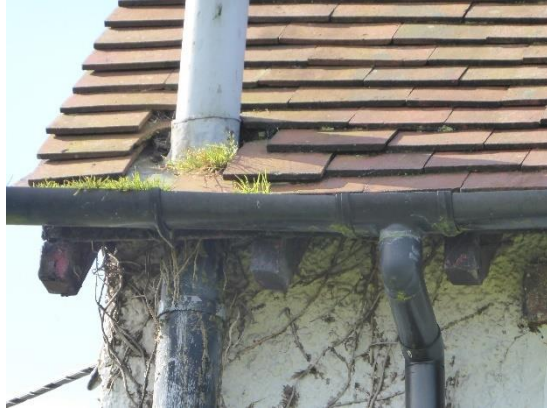
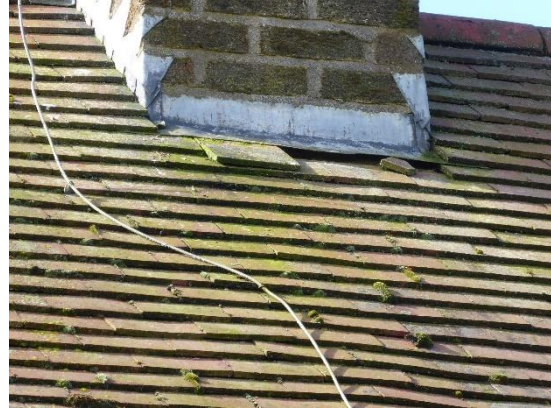
- Some of the tiles are damaged, loose, uneven and have slipped. Repairs are required to prevent water ingress.

Condition Rating 2.

Tile repairs required

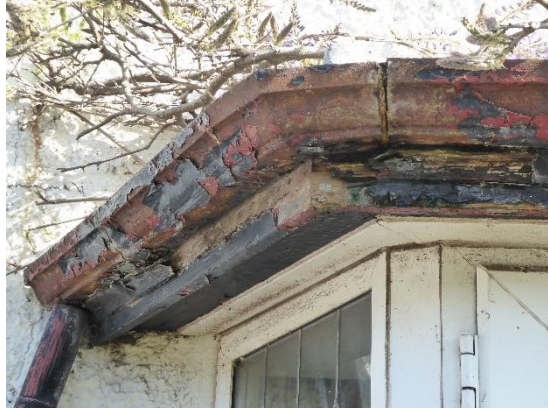
- The front bay gutters are corroded and leaking. These should be replaced to reduce the risk of future defects developing.
- Several plastic gutter and rainwater pipe joints are stained and possibly leaking. The rainwater goods should be repaired / sealed to reduce the risk of future defects developing.
- There is vegetation growth in the gutters which needs to be cleared to prevent overflowing and to reduce the risk of future defects developing.

Condition Rating 3.

Corroded/leaking cast-iron gutters

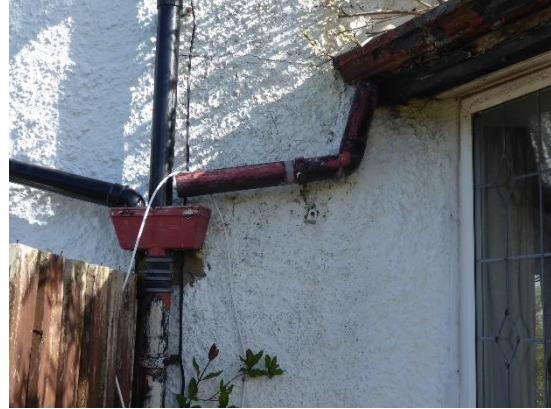
Leaking rainwater pipes

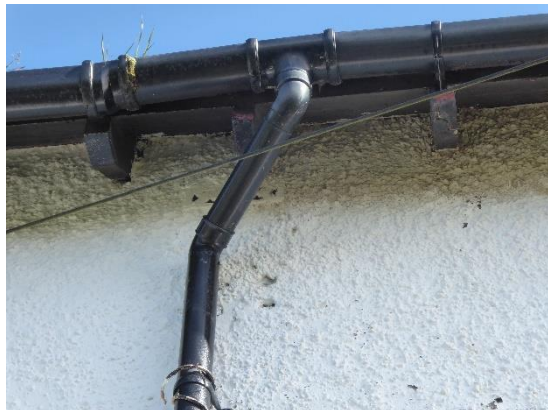
Leaking gutters

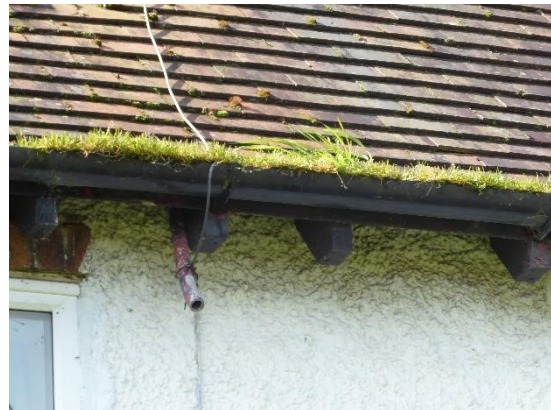
Vegetation growth

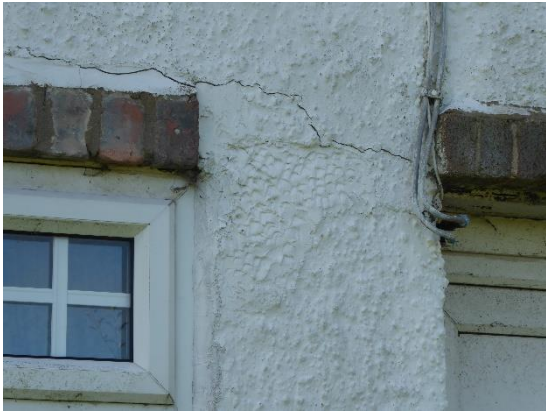
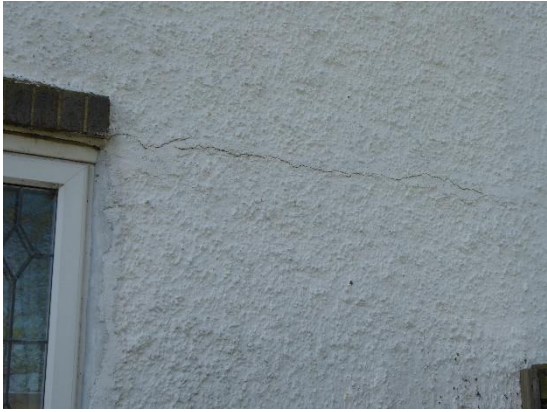
Masonry cracking has occurred over some of the window/door openings. Specifically, this was observed to the rear kitchen, dining room & lounge window/door openings.

It is suspected the cracking is caused by corrosion of existing metal lintels above the affected openings leading to cracking over time due to expansion from metal corrosion. It is also possible the cracking has been caused by previous window installation works where the masonry has been disturbed as a result of the installation process.

Cracking above window/door openings

- To avoid any progressive issues which would cause further damage and deterioration, further investigation is now recommended. The lintels to the affected openings should be exposed and inspected by a competent builder and all necessary remedial works carried out to prevent further deterioration.

If existing lintels are severely corroded they will need to be replaced. If found to be in a reasonably sound condition they should be prepared, treated and coated to ensure they are suitably protected against future weathering and corrosion. Associated masonry repairs will also be needed involving reinstatement of the cracked and damaged brickwork and the making good of the render finishes which will add to the overall cost of the remedial works.

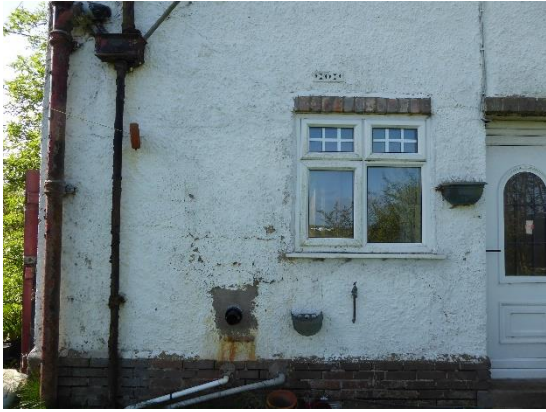
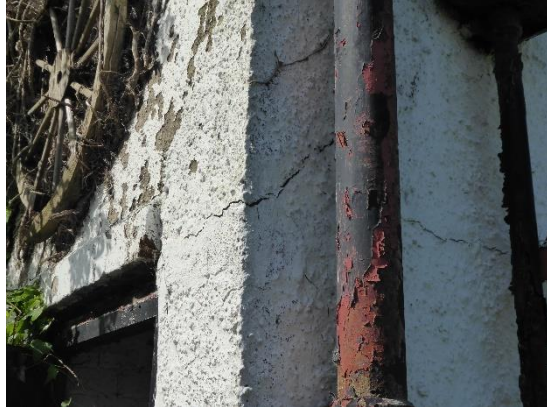
Cracking to rear corner

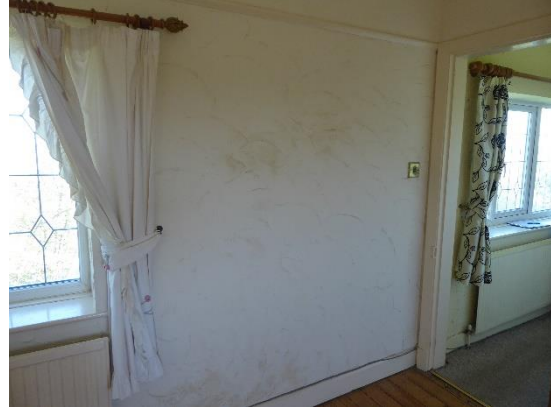
Internal cracking to landing area

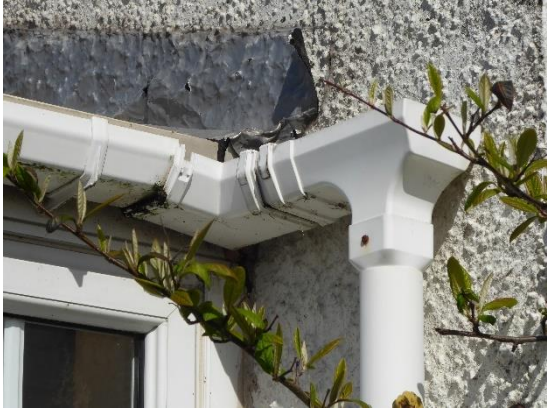
Loose rainwater fittings

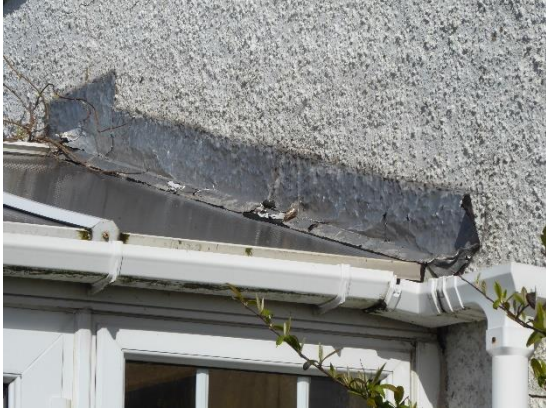
Temporary flashings

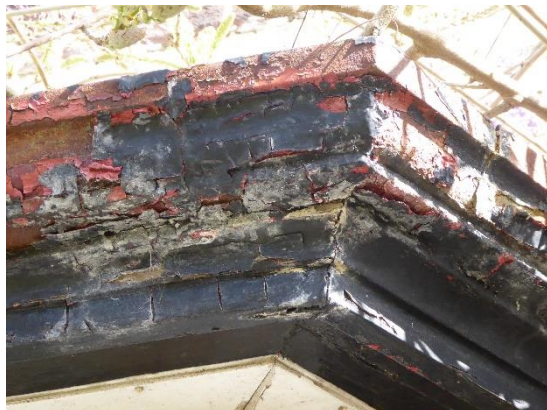
Evidence of decay

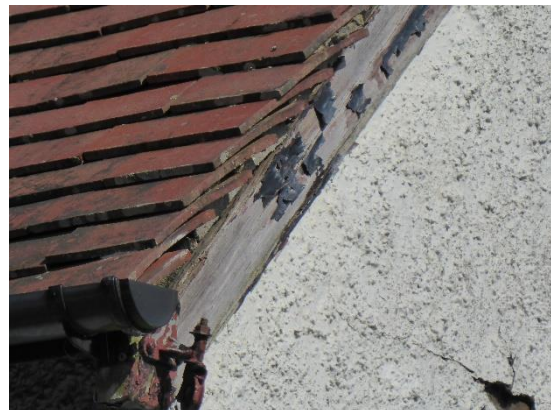
Weathered decorations

External decorations will need regular redecoration, typically on a three-to-five-year cycle dependent upon the quality of paint or stain coating. This should include all timber windows and doors.

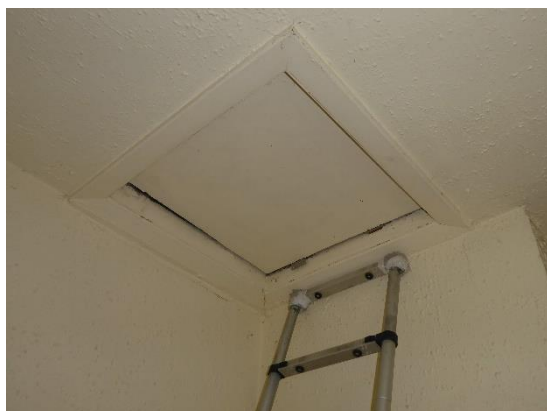
You should note that being inaccessible, there is a risk of defects being present which could be costly to repair such as the presence of wood boring beetle (woodworm) and timber decay.

Loft hatch – sealed/jammed shut

It is therefore recommended that once access is obtained, you arrange for a detailed inspection of the loft space/roof structure by an appropriately qualified person such as member the Property Care Association (or similar) and/or reputable building contractor in order to fully establish the extent of any defects within the roof space so that any necessary repairs/improvements can be estimated prior to purchase.

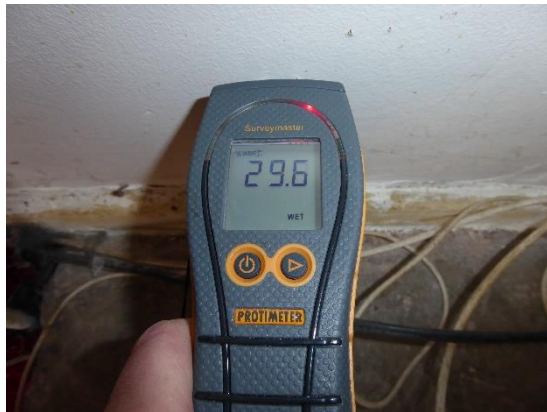
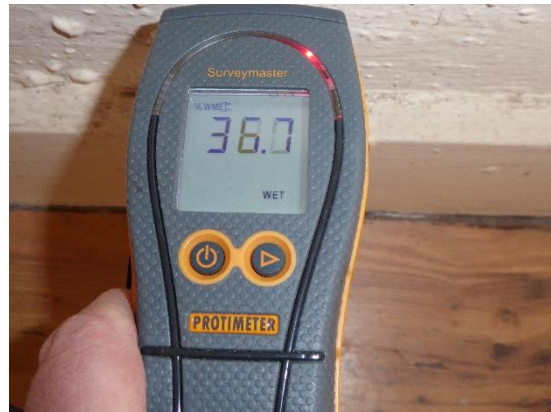
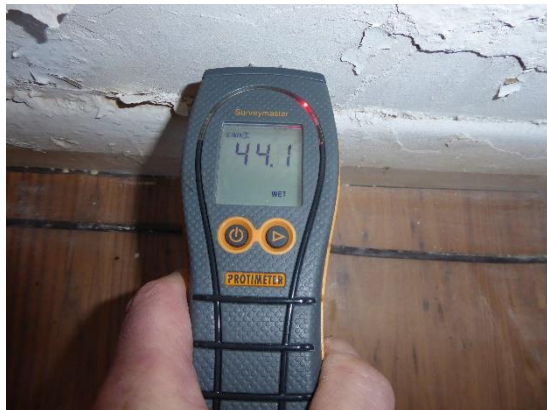
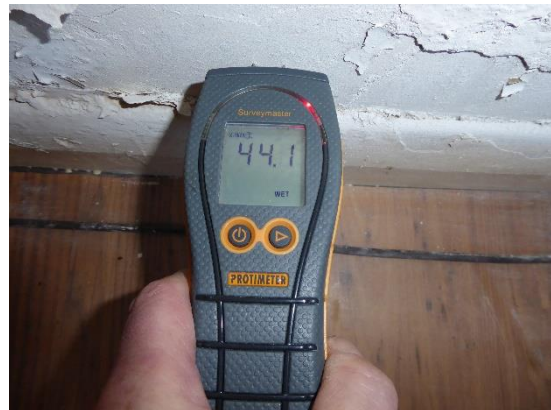
Evidence of dampness within the ground floor walls

Damp has been found within the walls. Whilst no corresponding timber defects were noted within the adjacent and fixed joinery items, there will be a risk of rot being present behind the timbers where they cannot be inspected. When undertaking further investigations and repairs for the damp found, further timber repairs may well become necessary and the scope and costs of remedial works may be extended.

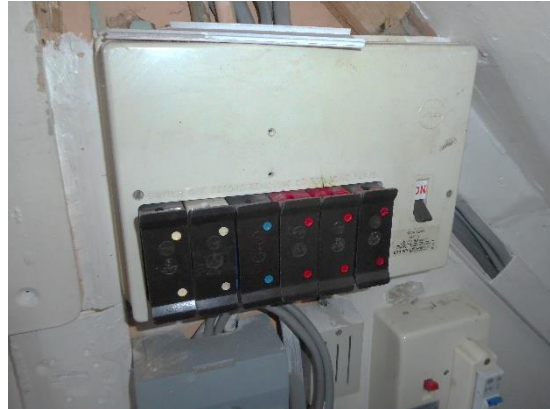
Dated consumer unit

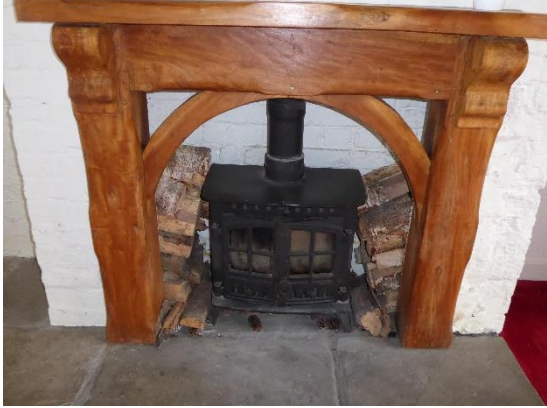
Solid fuel stove

- The stove should have Building Regulation approval or it should have been installed by a HETAS registered contractor or similar. Your Legal Adviser should check the validity of any service information and/or test certification for the stove. If there has been no inspection or test, where necessary, within the last 12 months then an inspection and service/safety test must be carried out before use.
- The property has no carbon monoxide alarm in the room containing the stove. This is considered a safety risk. Suitable alarms (preferably mains operated) should be installed at appropriate locations to give early warning.

Condition Rating 3.

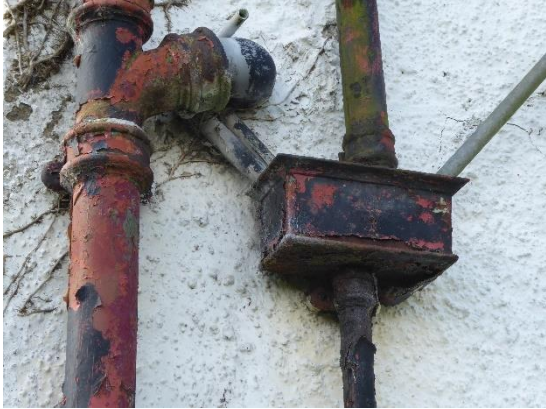
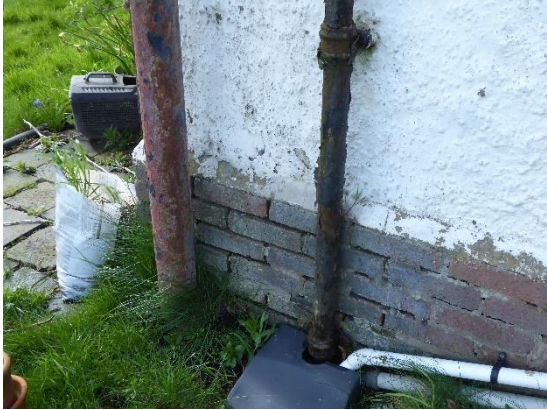
Corrosion to cast-iron sections

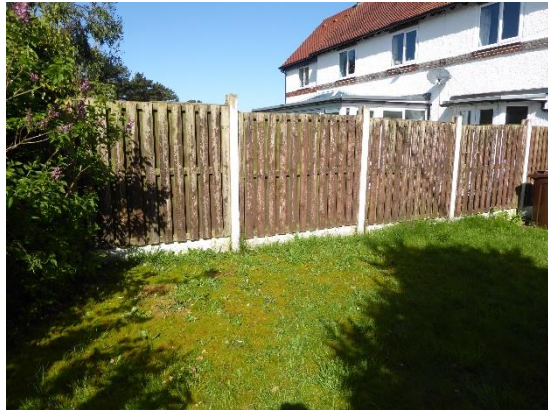
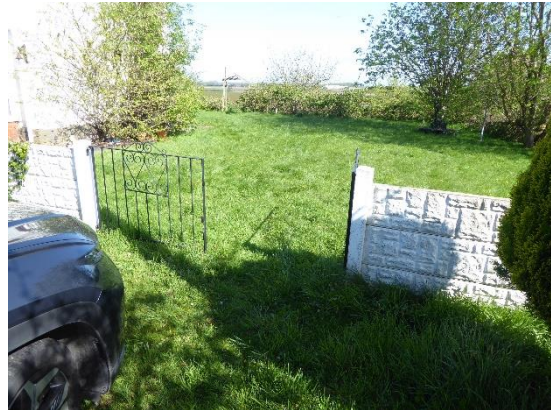
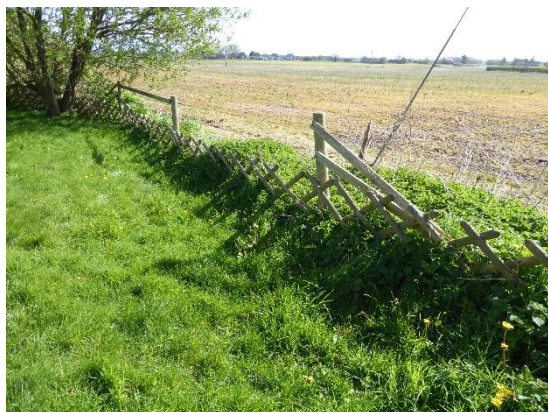
Boundary fencing
