LEVEL 3 HOME SURVEY

Detached property

Built 1850-1890

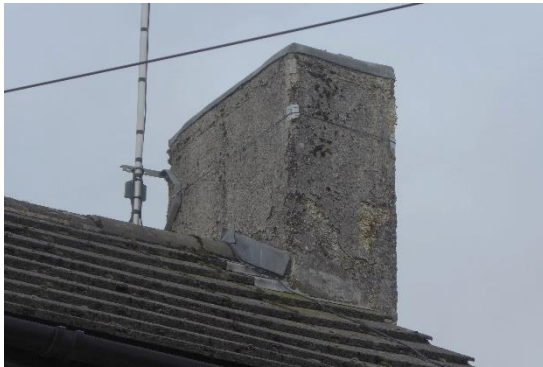
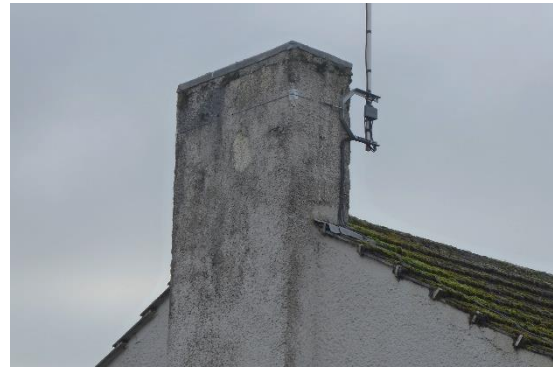
- No visible air brick was seen at the head of the stack in order to ventilate the redundant flue voids. Although no evidence of internal damp was noted at the time of the inspection, this could lead to a risk of condensation building up within the voids and consequent damp penetration in the surround areas. The flues should be ventilated via an air brick(s). Checks should also be made that the flues have been adequately capped at the same time.
- The need to provide a safe working platform and other difficulties associated with working at height makes repairs relatively expensive & you should therefore budget for this additional expense.

Evidence of movement in the form of leaning was noted to the stack; however, this is not deemed to be excessive. The stack should be regularly inspected and maintained as any deterioration of the masonry could lead to instability.

Chimney stack

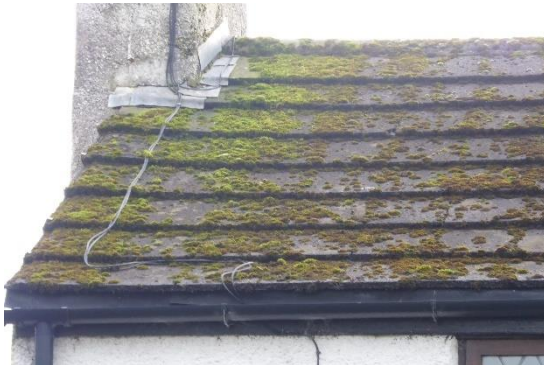
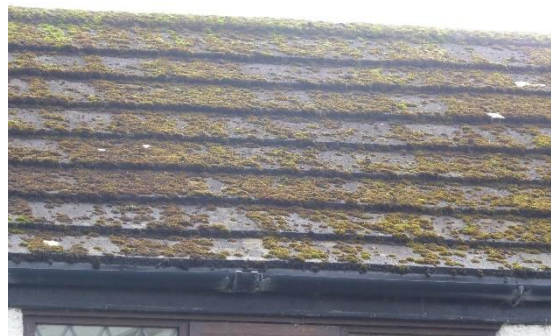
- There is heavy moss growth on the main roof, particularly to the rear. Left untreated, moss roots can be damaging to roof coverings and can cause tiles to deteriorate leading to water ingress and penetrating dampness issues internally. If loosened by heavy rain, moss can also roll into the guttering and cause blockages. It is recommended the moss is carefully removed to reduce this risk. Regular tree maintenance including clearing back any trees that are likely to cause shading can help to slow down the growth of moss.

Rear main roof

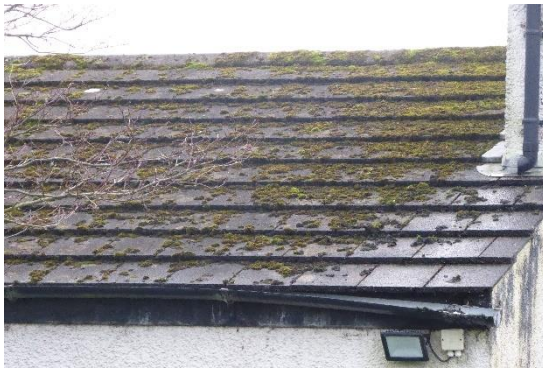
- The guttering to the rear of the extension is out of level & loose allowing rainwater to overflow. The guttering should be replaced to provide effective rainwater drainage.
- Some of the gutter joints are leaking. The gutters should be resealed/repaired to reduce the risk of future defects developing.

Out of level/loose gutter to rear extension

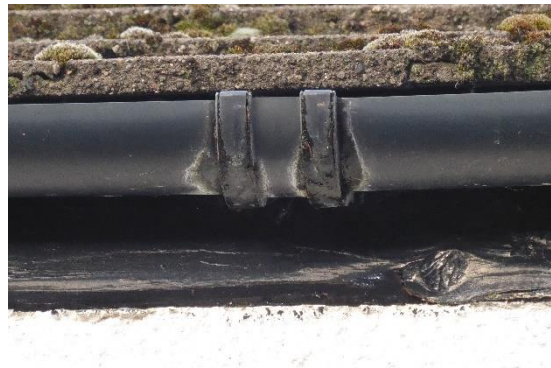
Leaking gutter joints

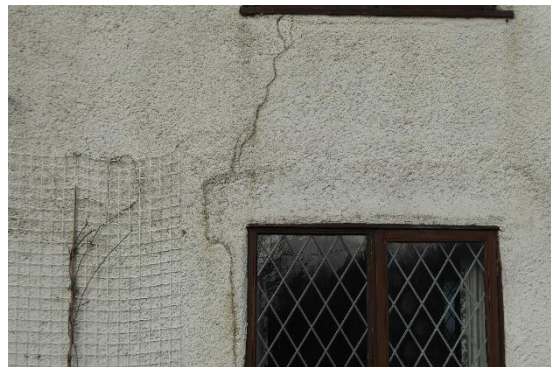
Render cracking

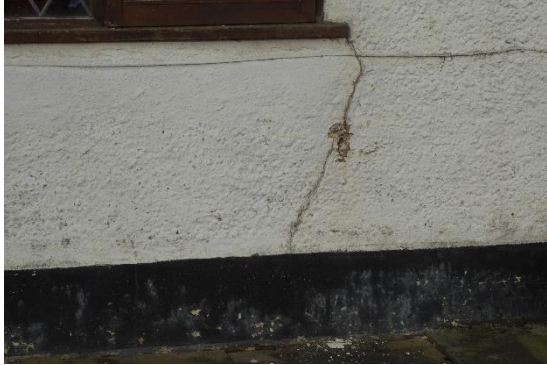
Render cracking

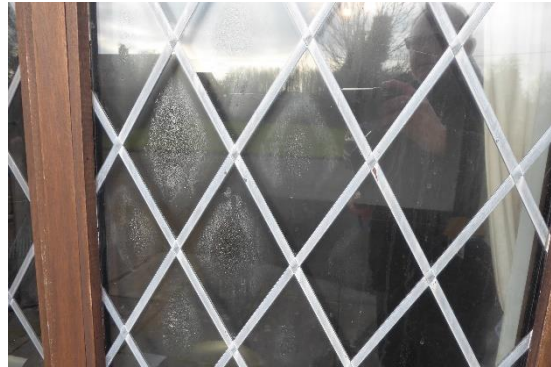
Misted double glazing

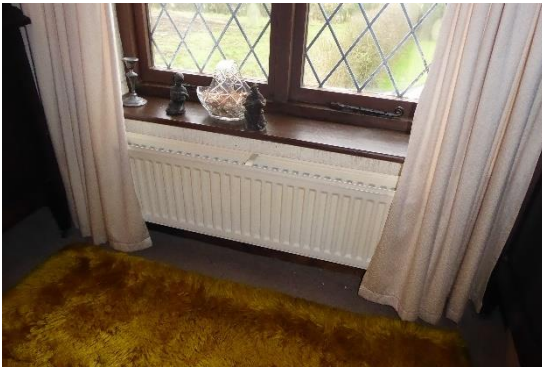
Safety concern – no safety glass

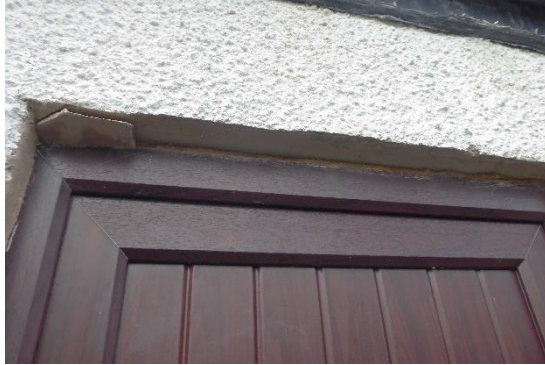
Front door – missing frame sealants

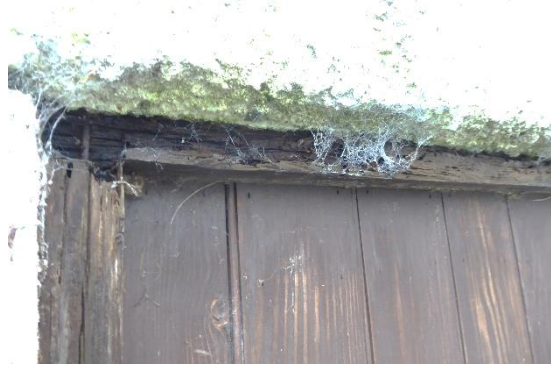
Decay to door frame

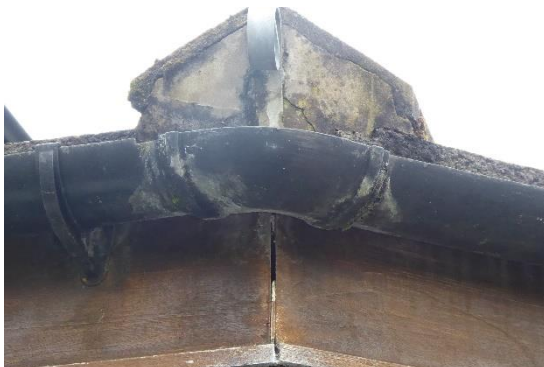
Leaking gutters

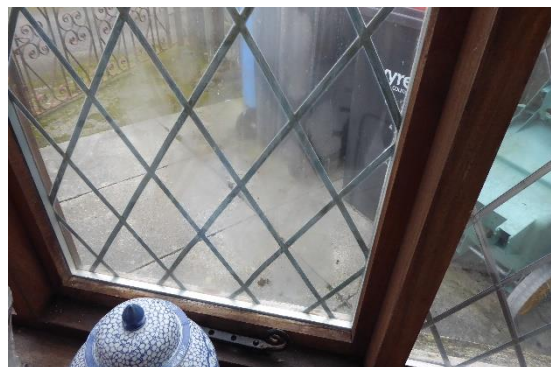
Misted double glazing

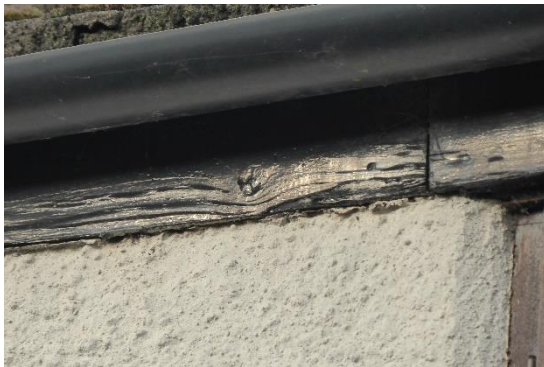
Weathered decorations

External decorations will need regular redecoration, typically on a three-to-five-year cycle dependent upon the quality of paint or stain coating. This should include all timber windows and doors.

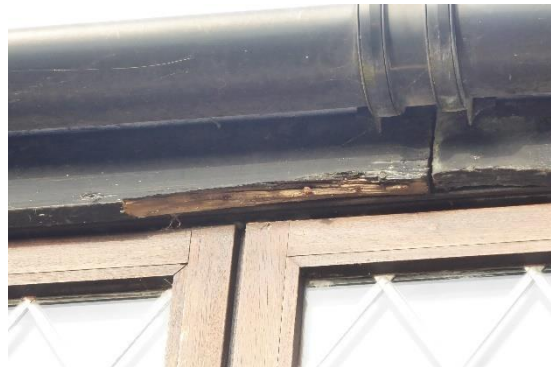
Evidence of decay

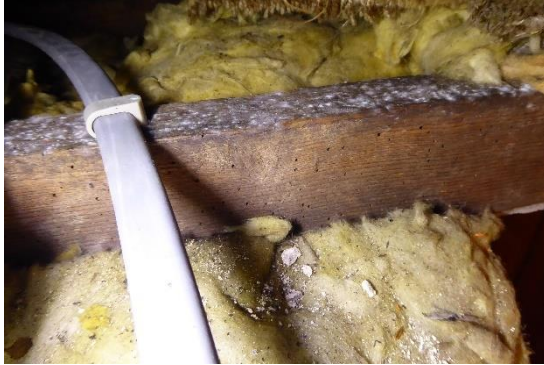
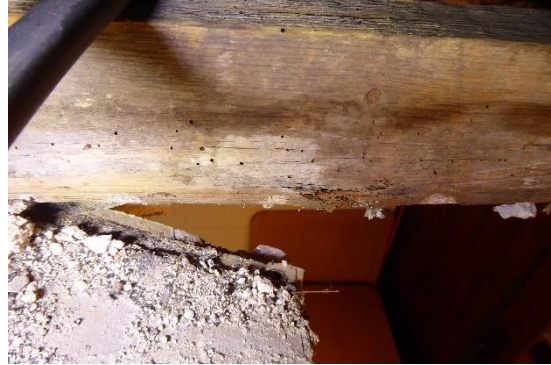
Evidence of wood woodworm infestation

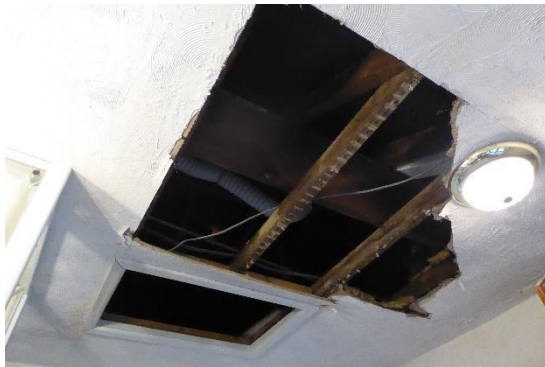
Water damaged Bathroom ceiling

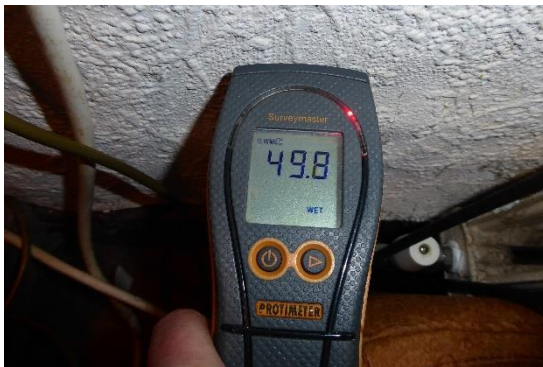
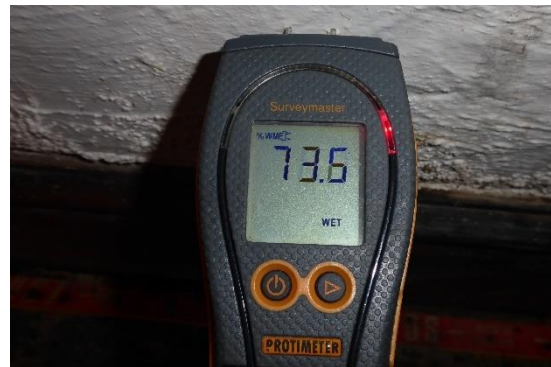
- High moisture meter readings were recorded to most of the walls at ground floor level.

The pattern of damp within the walls would indicate the most likely cause of the damp to be a combination of factors including rising dampness from the ground, deterioration or failure of the DPC, penetrating dampness through the wall structure, the deteriorating external wall surfaces and the old and porous wall masonry.

High moisture meter readings to the ground floor walls

Further investigation by an appropriately qualified person, such as member the Property Care Association is needed in order to fully establish the extent of damp within the property and confirm its precise cause so that a remedial treatment plan can be advised. As a precaution, the whole

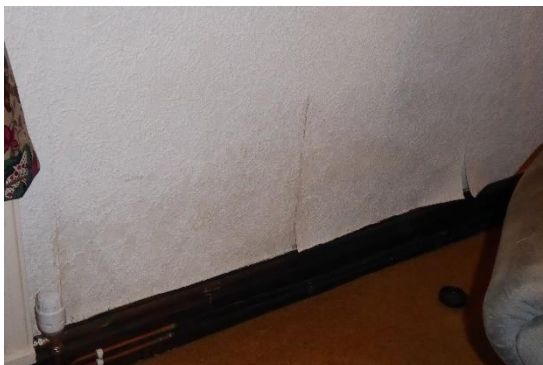
Damp staining to ground floor walls

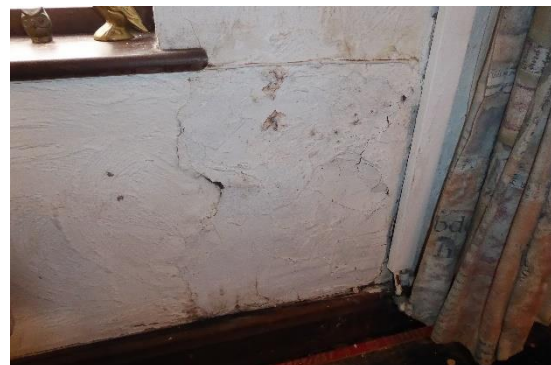
Textured finishes installed up until 1999 may contain asbestos fibres, although the use of the material was reduced from 1983. If left undisturbed, these finishes pose no threat to health and no action is required. Specialist advice must be obtained should they need to be disturbed.

Textured finishes that may contain asbestos fibres

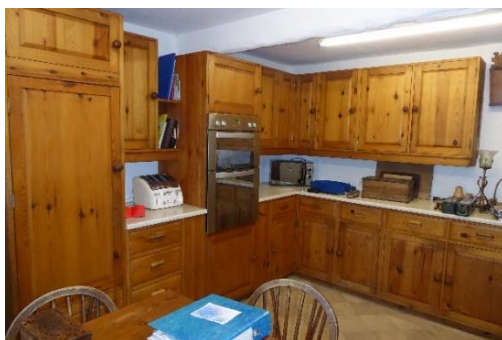
The fittings are dated and you should consider replacing them as part of your future ownership. You should obtain estimates for this from an appropriately qualified person such as a competent joinery contractor or kitchen fitter before a commitment to purchase.

Kitchen fittings

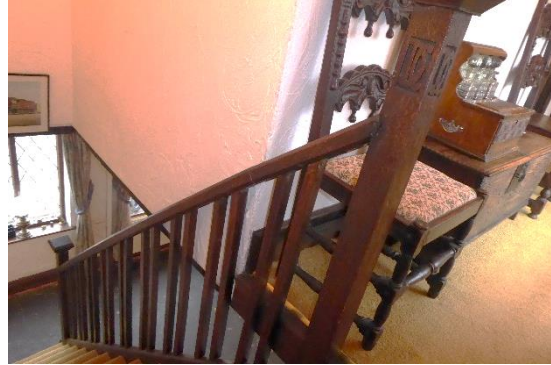
Loose balustrade

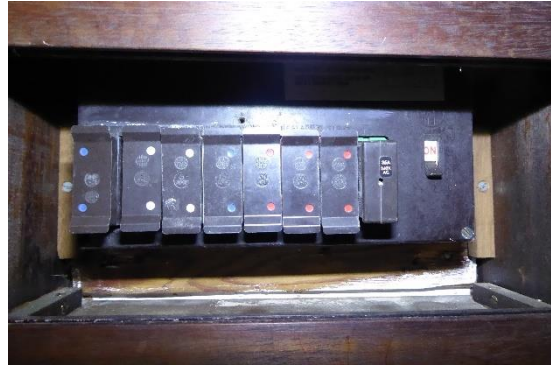
Dated consumer unit

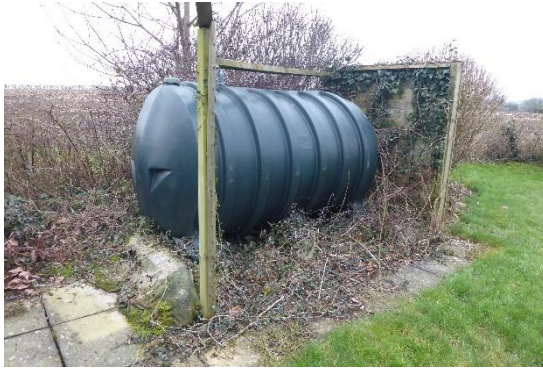
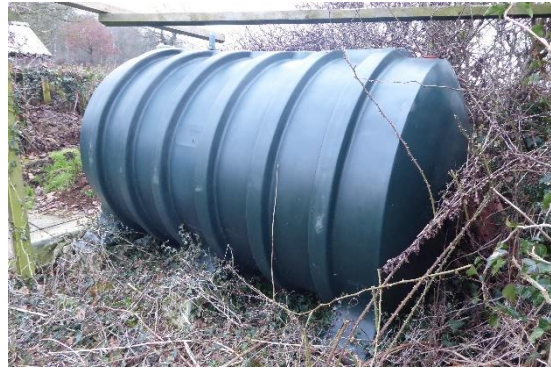
safety and carry out any necessary works. Oil leaks can cause serious environmental damage and can be very costly to remedy.

Oil storage tank

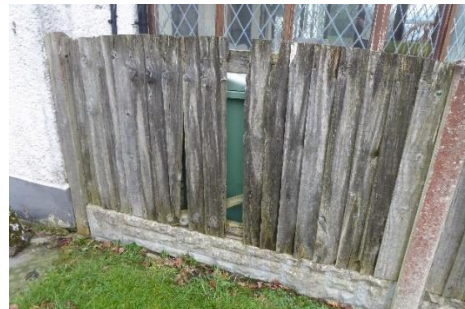
Decayed boundary fencing
