Home Condition Survey

Date: 05-Mar-2016

Surveyor: Mr Neil Maudsley

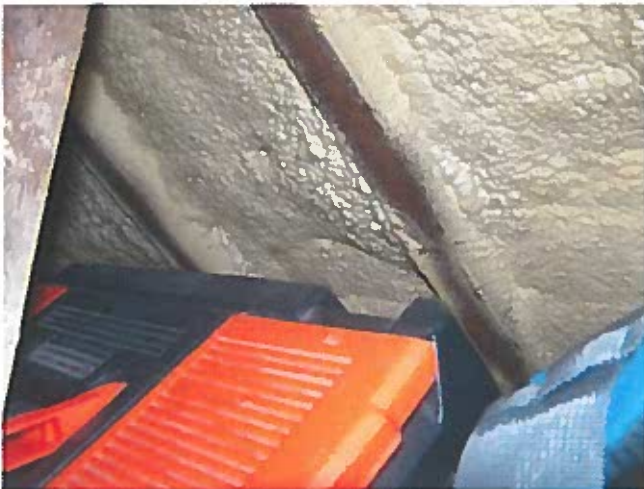
INSULATION.JPG

E1. Roof structure	Description and Justification for Rating and any comments	Condition Rating
	<p>It was not possible to inspect the roof structure due to the roof room conversion. Limited access however was available via the access door into the residual loft space/void.</p> <p>It was possible to confirm the following from this limited inspection: The main roof structure is constructed using individual timbers in a traditional manner including rafters, purlins & ceiling joists.</p> <p>The main roof is of original construction with spray foam insulation underneath the roof timbers (called rafters). This type of work is normally covered by a warranty but no information was available to view at the time of the inspection.</p> <p>The ceilings are likely to be made from lath & plaster which is typical of the properties age of construction. However, it was not possible to confirm this due to the presence of stored items.</p> <p>The timber roof frame/roof covering is not ventilated. A lack of ventilation can cause condensation to build-up in the roof space causing timbers to rot.</p>	1

<p>No repair is presently required. Normal maintenance must be undertaken.</p>

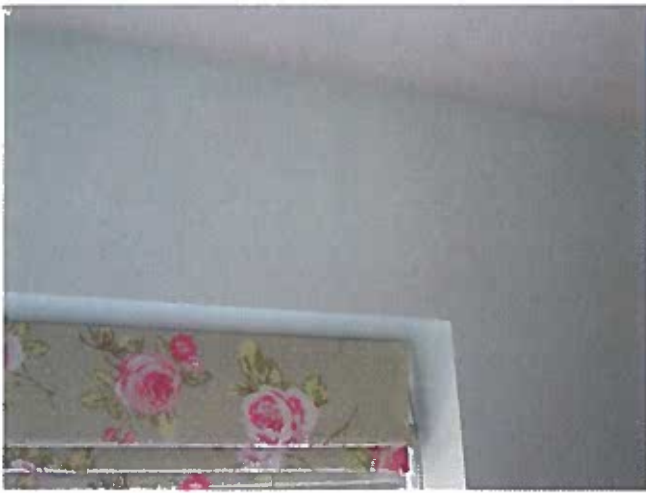
INT CRACKING 1.JPG

There is evidence of structural cracking to the window openings. This is ongoing requiring further investigation. For more information please see (Section D/Section E).

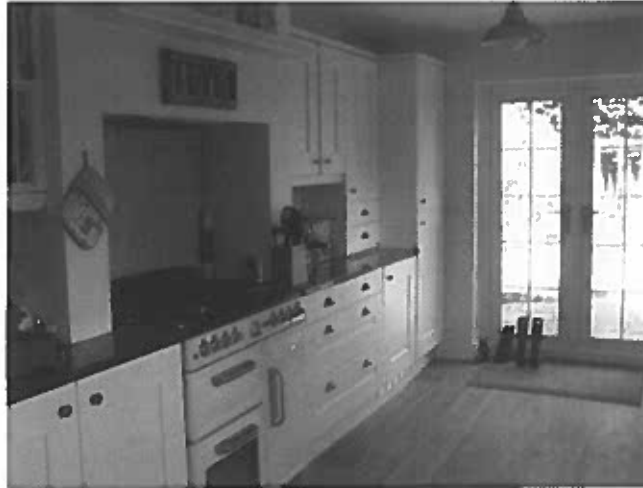
KITCHEN.JPG

Modern copper piping is present to the kitchen sink taps & plastic fittings are present to the wastes.

No repair is presently required. Normal maintenance must be undertaken.
