Home Condition Survey

Date: 12-Nov-2016
Surveyor: Mr Neil Maudsley

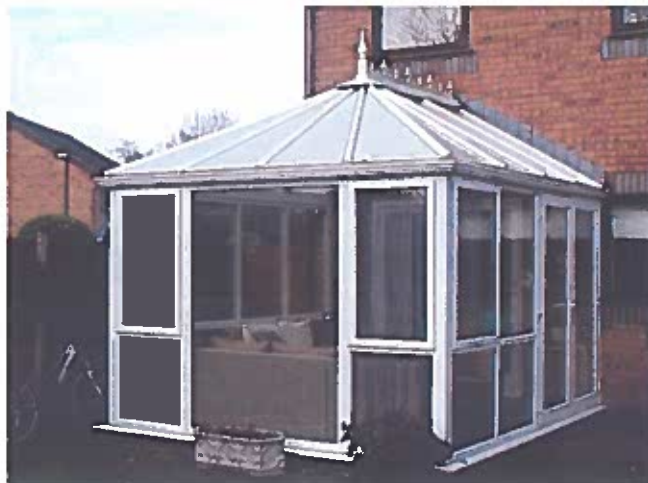
PB120090.JPG

The conservatory is generally in a satisfactory condition. No defects were observed.

No repair is presently required. Normal maintenance must be undertaken.

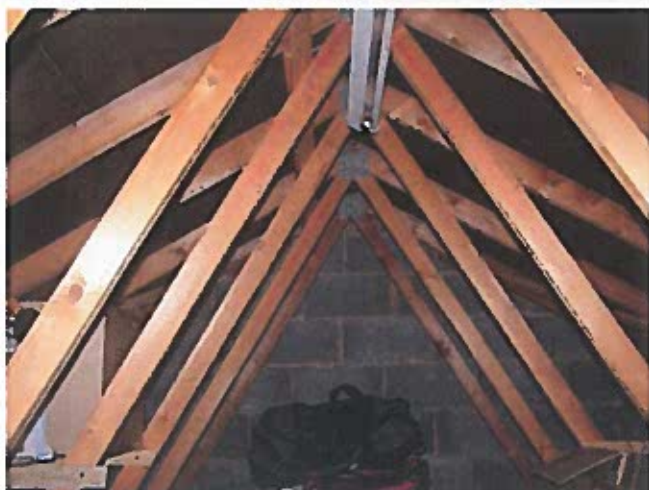
PB120006.JPG

E1. Roof structure	Description and Justification for Rating and any comments	Condition Rating
	<p>The main roof structure was viewed from ladders via the loft hatch on the landing ceiling. The main roof structure (ceiling) is partly boarded over for storage purposes.</p> <p>The main roof structure is constructed using modern timber trussed rafter construction and is the original construction. The main roof is of original construction with a secondary waterproof barrier of underfelt underneath the tiles.</p> <p>The main roof void has mineral wool insulation on the top of the ceiling between the ceiling timbers (called joists). The overall depth of the insulation is approximately 300mm.</p> <p>The ceilings are likely to be made from modern plasterboard which is typical of the properties age of construction. However, it was not possible to confirm this due to the presence of insulation.</p> <p>The cold water tank is located in the loft area in addition to the feed & expansion tank (central heating). Both of these storage tanks (plastic) & copper piping are insulated with lagging.</p> <p>The timber roof frame/roof covering is not ventilated. A lack of ventilation can cause condensation to build-up in the roof space causing timbers to rot over time.</p> <p>No repair is presently required. Normal maintenance must be undertaken.</p>	1

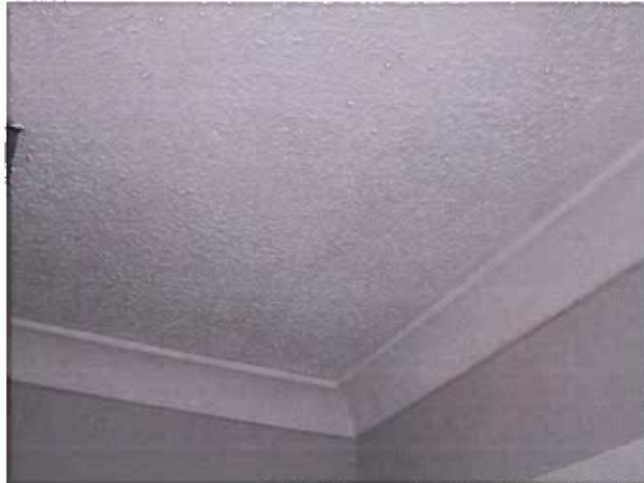
PB120019.JPG

Normal maintenance/decoration is required.

No repair is presently required. Normal maintenance must be undertaken.

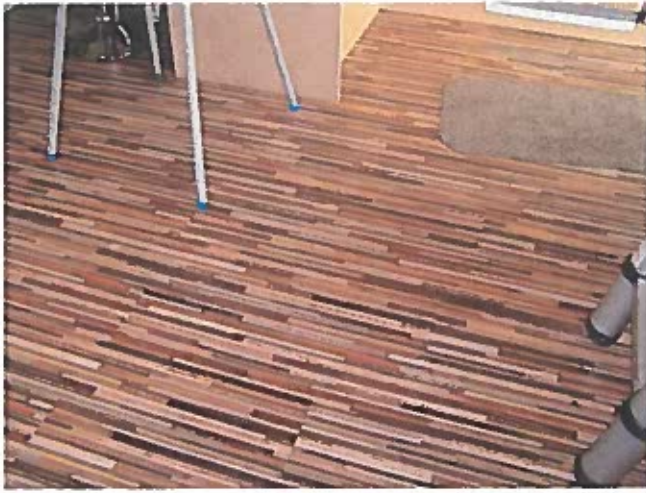
PB120037.JPG

Subject to limitations of floor coverings, especially fixed floor coverings as well as heavy furnishings and stored items, no significant defects were apparent to any of the floors within the property.

No repair is presently required. Normal maintenance must be undertaken.

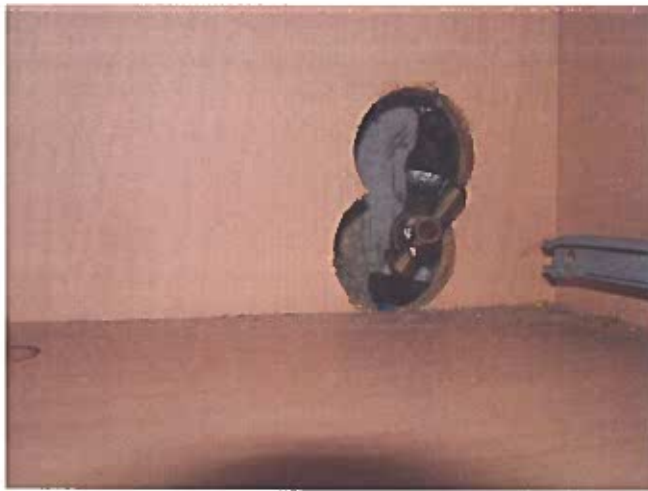
PB120002.JPG

The water mains pressure was tested by running the kitchen cold water tap & is satisfactory.

Normal maintenance must be undertaken.

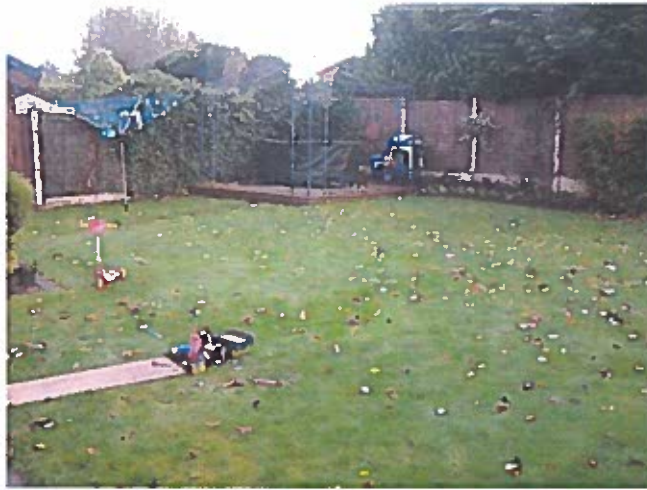
PB120084.JPG

The grounds are mainly laid to lawn.

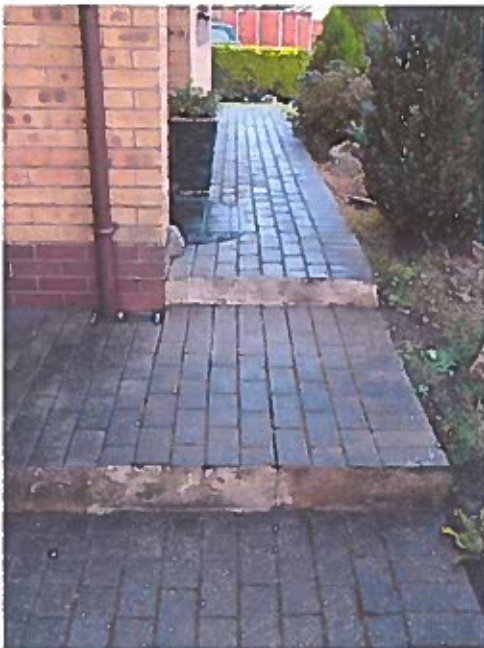
PB120064.JPG

Paved areas There is a driveway to the front of the property with a tarmac surface.

The front/side/rear areas of the property are covered in a combination of concrete paving flags & concrete block paving.

The paved areas are generally in a serviceable condition.
