SAMPLE REPORT 2
LEVEL 2 HOME SURVEY

Detached property

Built 2001

LEVEL 2

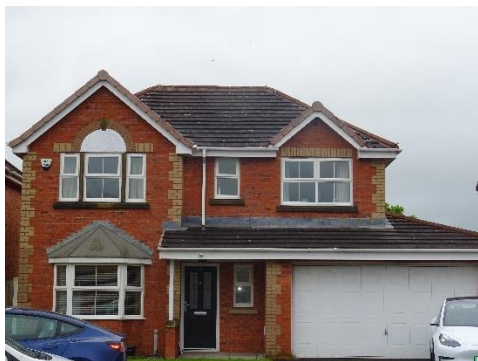
Front elevation

As a general comment, the main walls are in satisfactory condition overall and free from serious defects. They are however weathered in a manner that is to be expected bearing in mind the age of the building:

- The property appears free from any significant structural movement to external walls. No evidence was seen of any significant cracking which might indicate that the property is subject to subsidence, unusual settlement, or other exceptional movement of the ground.

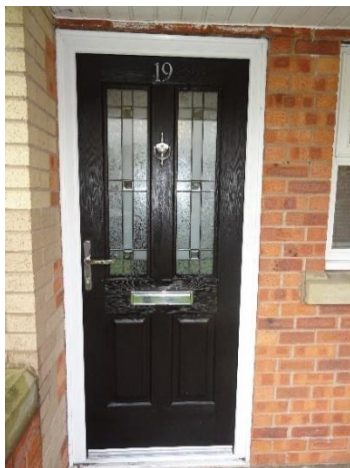
Front door

- The doors are slightly worn and weathered but are in satisfactory condition for their age. The doors were checked for operation and were found to be generally in a serviceable condition although some wear and tear is evidence to the door furniture from use. The sealant to the frame surrounds also appeared free from any significant deterioration. There were no signs of condensation between double glazed panes at the time of inspection. The doors are generally in satisfactory condition overall. Despite this, however, on-going maintenance will be required during your future occupation of the property.

Condition Rating 1. Normal maintenance will be required.

Please refer to my comments in Section D5 regarding double glazing seals, seals to the frames, any guarantees and the provision of any keys. It is recommended you change all locks upon occupation to enhance security.

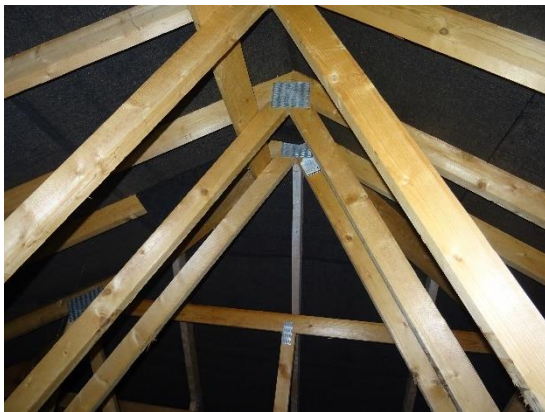
Main roof structure

- Where accessible and visible the roof structure is in reasonable order. No significant distortion was noted to the timbers and the space appears to be adequately ventilated and insulated.
- Bracing between individual trusses appears to be adequate with no movement noted. No cutting out of these timbers should be contemplated without first seeking advice from a Chartered Structural Engineer or a Building Surveyor.

Condition Rating 1. Normal maintenance will be required.

Roof structures require ventilation in order to ensure any moisture and condensation is taken to atmosphere. Where this is trapped it can cause increased moisture content in roof timbers that can lead to consequential timber defects forming. You should ensure the soffit vents are not obstructed / blocked to ensure a sufficient flow of air through the void.

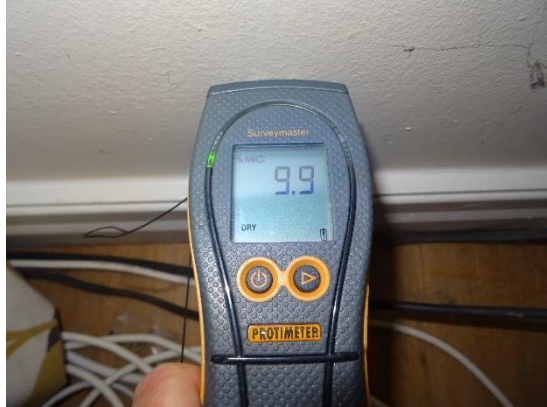
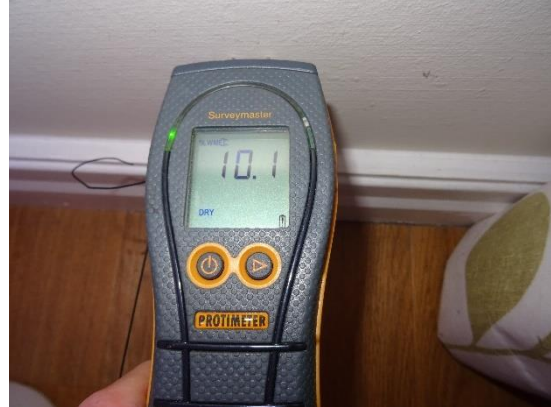
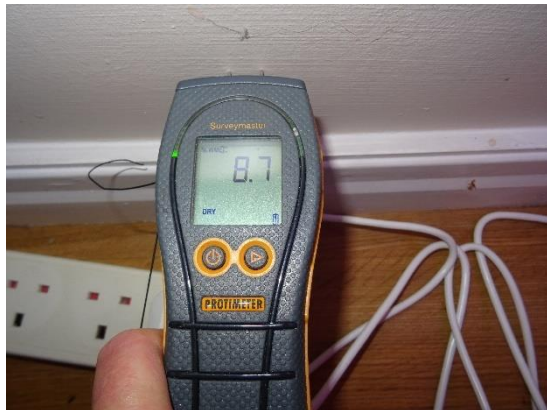
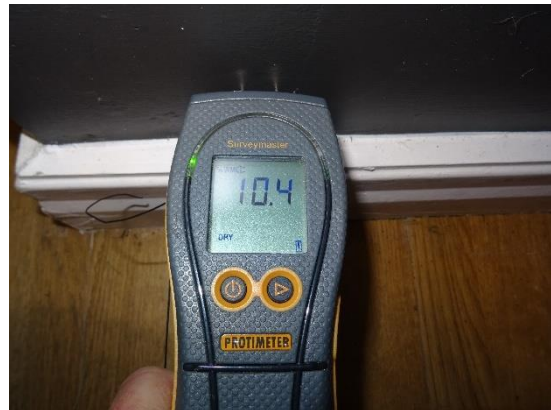
Moisture meter readings – generally dry

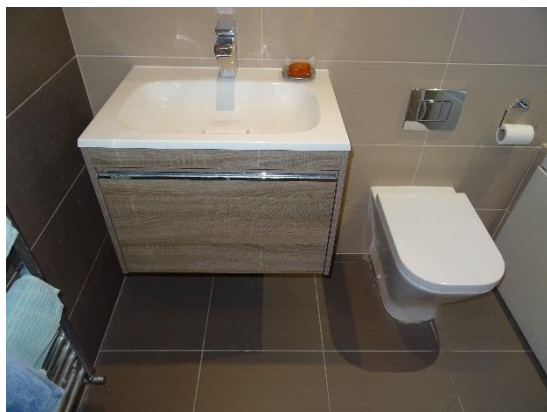
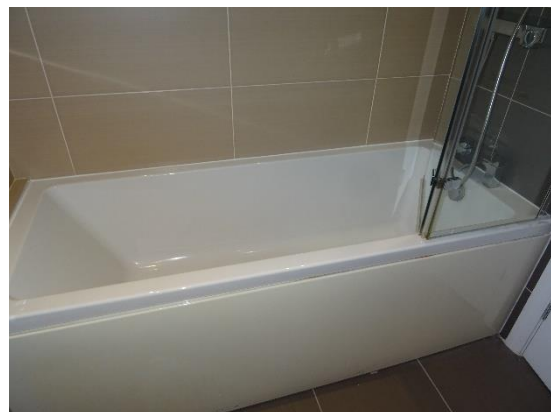
Bathroom fittings

In other respects, the fittings are in satisfactory condition but there is evidence of normal wear and tear from use. It is important that the seals around the fittings are not allowed to deteriorate as this could allow leakage that might result in damage. You should check the integrity of the seals at regular intervals and have them renewed at the first sign of deterioration.

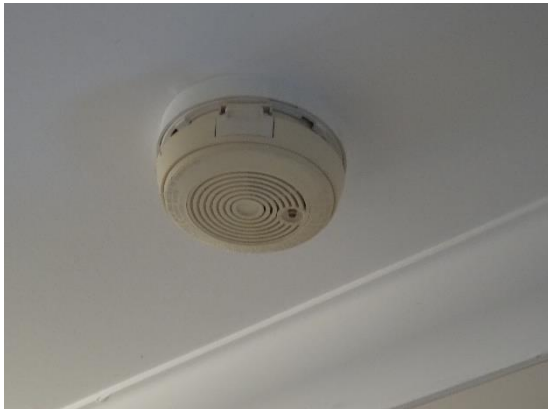
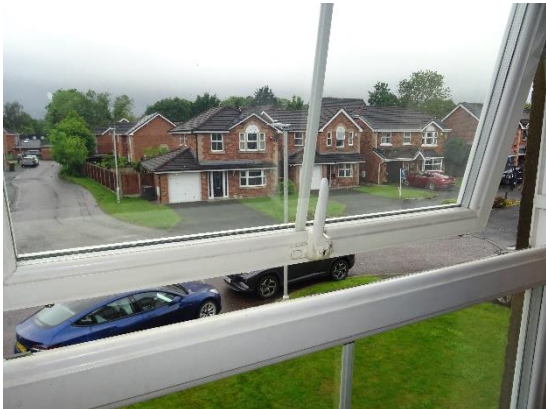
- Fire precautions for the property appear satisfactory.

Condition Rating 1.

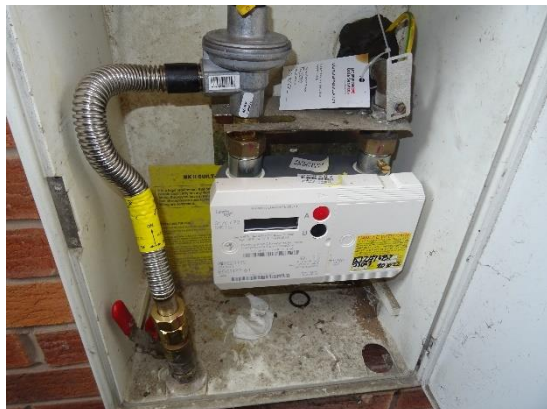
Gas meter and stop valve

Condition Rating 3.

- Your Legal Adviser should establish whether there is a current test certificate available and if not then it should be checked before purchase and you should immediately instruct a Competent Person such as a Gas Safe registered engineer prior to exchange of contracts to inspect and test the installation for safety and carry out any necessary works. You should also ensure that the gas appliances are serviced annually.

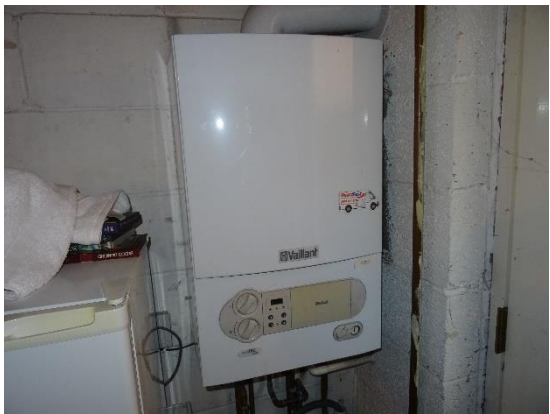
Boiler

Condition Rating 3.

- Your Legal Adviser should establish whether there is a current test certificate available and if not then it should be checked before purchase and you should immediately instruct a Competent Person such as a Gas Safe registered engineer prior to exchange of contracts to inspect and test the installation for safety and carry out any necessary works. You should also ensure that annual servicing of the appliances takes place.
- It is not possible to indicate the condition of flues or the presence of flue liners. As a precautionary measure, we would advise that the gas fire is serviced and examined by a Gas Safe registered contractor to ensure both the safe and efficient operation of the appliance and the flues. The contractor should also confirm that adequate ventilation has been provided to this appliance.
