SAMPLE REPORT 3

LEVEL 3 HOME SURVEY

Semi-detached property

Built 1935

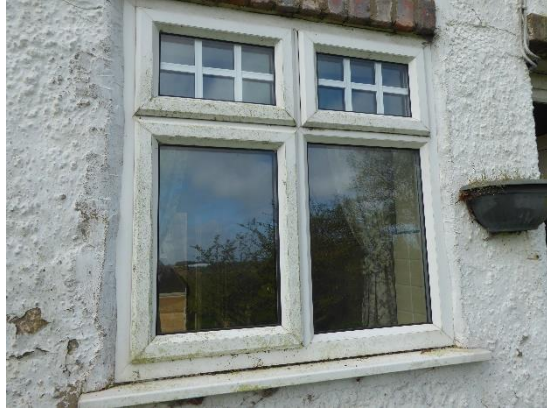
Upvc windows

The windows are of uPVC double-glazed frames throughout. The age of the windows is not known but based on their overall appearance and general condition they appear to be of some age.

In other respects, the windows are weathered and slightly worn but are generally in reasonable condition allowing for age. The sealant to the frame surrounds also appeared free from any significant deterioration. Checks were made for internal damp ingress to the window sills and frame reveals and no damp was found. It is essential that the seals between the window frames and the walls are regularly checked and kept in good condition to reduce the risk of water ingress and damp.

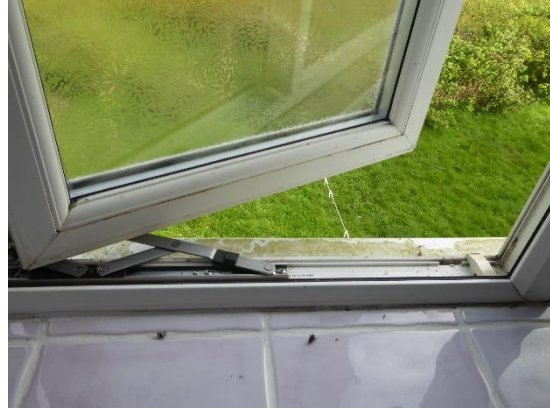
Opening casements

- Some window openings are stiff and difficult to operate (open and close) and some of the window handles are worn & loose. A general overhaul is required together with thorough easing, adjustment, and attention to window furniture which should be repaired or replaced.

Condition Rating 2.

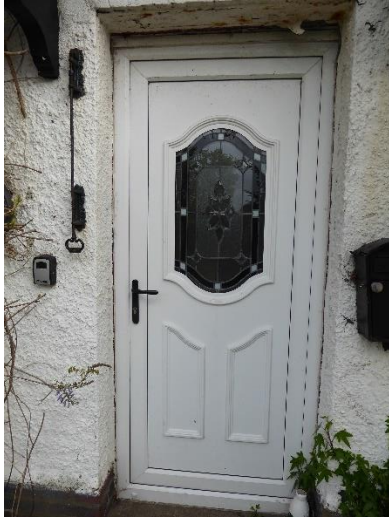
Front door

- The doors are slightly worn and weathered but are in satisfactory condition for their age. The doors were checked for operation and were found to be generally in a serviceable condition although some wear and tear is evidence to the door furniture from use. The sealant to the frame surrounds also appeared free from any significant deterioration. There were no signs of condensation between double glazed panes at the time of inspection. It should be noted however that on-going maintenance will be required during your future occupation of the property.

Condition Rating 1. Normal maintenance will be required.

Please refer to my comments in Section D5 regarding double glazing seals, seals to the frames, the need for statutory approval, any guarantees and the provision of any keys. It is recommended you change all locks upon occupation to enhance security.

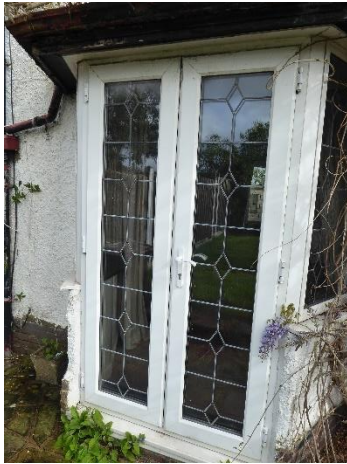
Lounge doors

The glass in the lounge doors has no markings to indicate toughened or laminated safety glass is present. To reduce the risk of injury from accidental breakage the glass should be tested by a glazing specialist to confirm it complies with the relevant British Standard. If it fails to comply this is a safety risk and the glass should be replaced.

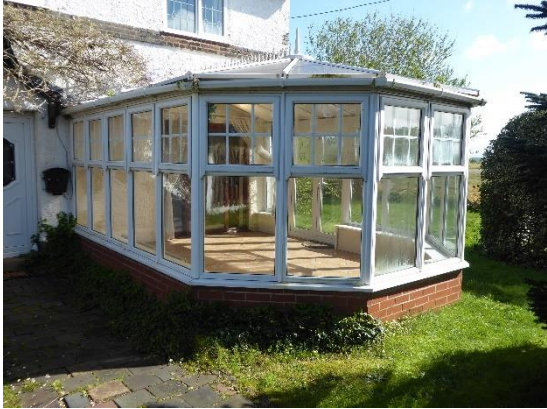
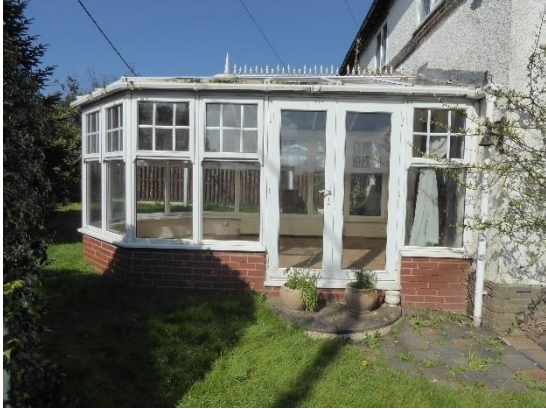
Conservatory - external

- The self-adhesive flashings are of poor quality and designed for patching purposes only. This should be replaced with a more durable material such as lead to reduce the risk of future defects developing.
- The glazing in some of the windows has misted over due to failure of the seals. This cannot be repaired and the affected panes need re-glazing.
- The downpipe is not connected to the gutter. This should be re-connected to reduce the risk of leakages and future defects developing.
- The gutters are poorly aligned. Repair is needed to reduce the risk of future defects developing.
- There is vegetation growth in the gutters which needs to be cleared to prevent overflowing and to reduce the risk of future defects developing.

Condition Rating 2.

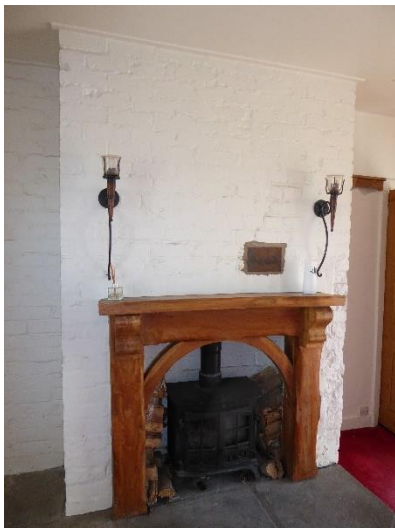
Chimney breast - lounge

The internal condition and serviceability of any flue cannot be determined from a visual inspection. Old unlined flues will inevitably deteriorate with age as the acidic products of combustion erode the bricks and mortar joints. As a result they may not be completely smoke and fire tight. For this reason they should be cleaned and smoke tested before use.

If you intend to bring the disused fireplaces back into use some repair and upgrading may well be required and the flues may need repair or lining which could be costly. If this is your intention you should seek specialist advice before proceeding.

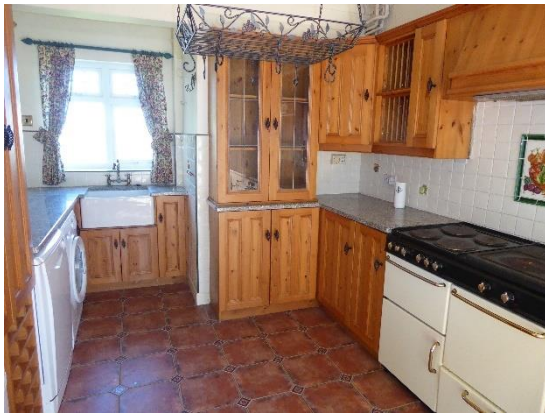
Kitchen fittings

In other respects, the kitchen fittings are in satisfactory condition allowing for normal wear and tear from use. Normal maintenance will be required.

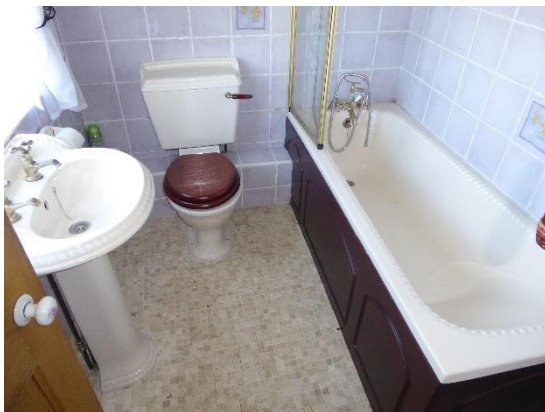
Bathroom fittings

Condition Rating 2.

In other respects, although dated, the fittings are in reasonable condition but there is evidence of normal wear and tear from use. It is important that the seals around the fittings are not allowed to deteriorate as this could allow leakage that might result in damage. You should check the integrity of the seals at regular intervals and have them renewed at the first sign of deterioration.

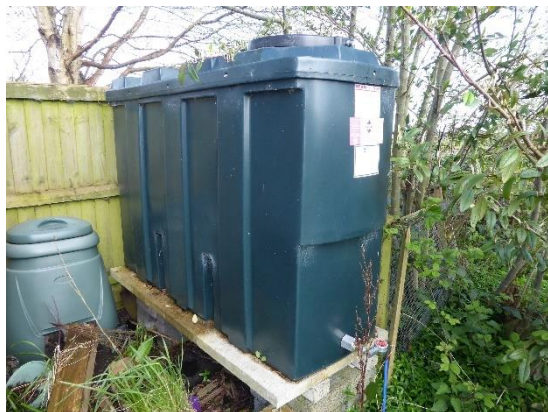
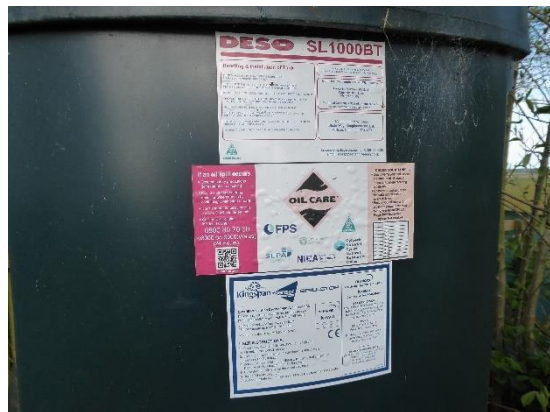
Oil storage tank

Condition Rating 3.

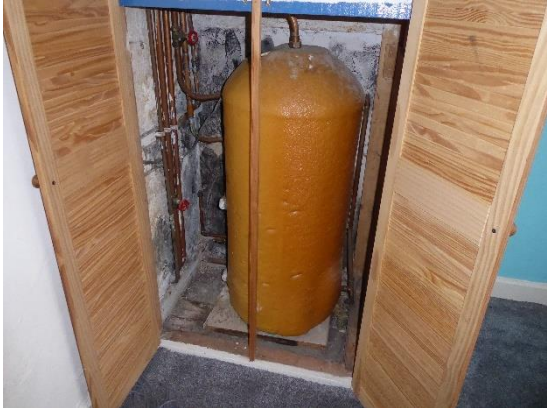
Hot water cylinder

- Hot water is provided by the boiler and you should see our comments in Section F4 above.

Condition Rating 3.
