LEVEL 3 HOME SURVEY

Detached property

Built 1850-1890

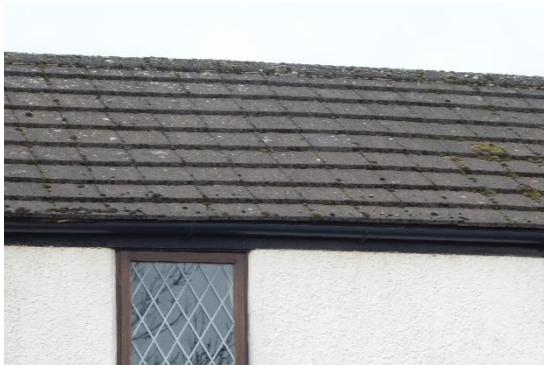
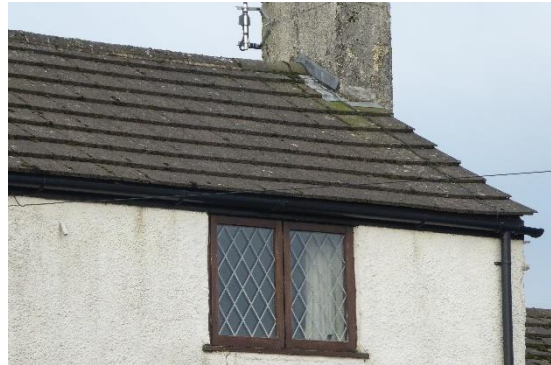
Front main roof

ridge tiles appear to be firmly fixed in place; however, it is not uncommon for these to become dislodged by high winds and occasional refixing of these must be anticipated. Despite this, you should check the roof coverings on a regular basis and they should be maintained in good condition. Small items of disrepair if left unattended can lead to costly problems. You should note, however, that the exposed position of the property will lead to a greater exposure to weathering elements and wind damage, particularly in storm conditions. A higher incidence of repair and maintenance is to be anticipated as a result.

The roof underlining could not be seen at eaves level and I cannot confirm its condition or whether it properly laps into the guttering. Felt deteriorates when exposed to sunlight. This increases the risk of water ingress at eaves level. I found no evidence of any damp related problems as a result, but if defects are found on closer inspection or begin to appear in the future it will be necessary to strip back the roof covering from the edge to allow the felt to be repaired or replaced.

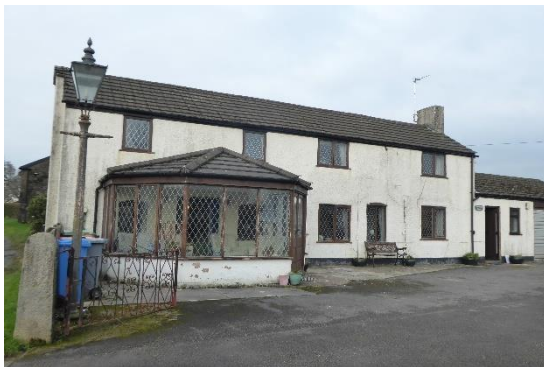
Front elevation

- There is evidence of structural movement in the form of render cracking above and below the Kitchen window opening on the front elevation.

Such movement is not unusual in buildings of this age. The movement appears historic and is believed to be due to old settlement within the structure. Often type of this cracking is focused on the weakest areas of the walls which are the openings of windows and doors. There was no evidence of corresponding movement and/or cracking internally in this area and further significant movement is therefore unlikely to occur.

The cracking to the render surfaces, however, could be different from that within the masonry behind and on removal of the render finishes it is possible that further localised cracking and loose brickwork may be discovered that may require some masonry repairs.

- It is recommended the cracked render is carefully removed to enable inspection of the exposed brickwork. This should be carried out by a reputable contractor with experience in dealing with structural remedial repairs & who will be able to provide a quotation. Render repairs will be required on completion of any necessary masonry repairs.

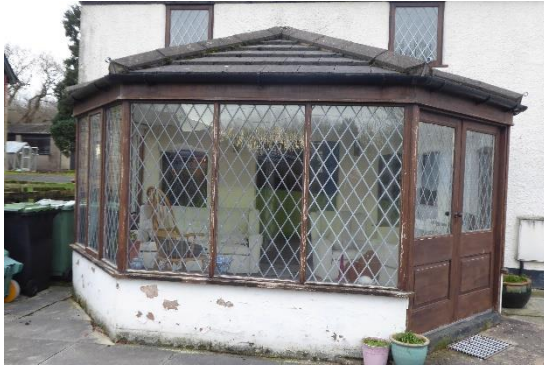
Sun Room - external

Our enquiries indicate that no such statutory approvals were obtained. If the Sun Room is important to your purchase of the property, you should obtain advice from your Legal Adviser. It may be possible to apply for a retrospective building regulations Completion Certificate via the Regularization process or an indemnity insurance policy if in your Legal Advisers opinion may provide sufficient financial cover in the event the works are non-compliant.

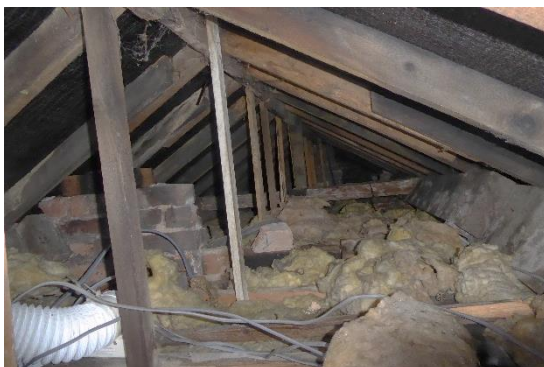
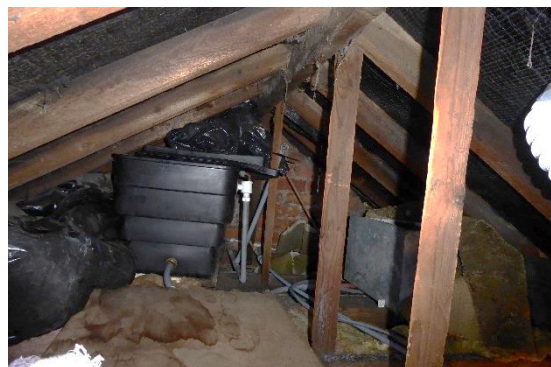
Main roof space/roof structure

The original main roof covering has been replaced with tiles which will be heavier than the original covering (probably slates). No structural defects were observed as a result; however, these works will have required Building Regulation approval. Your Legal Adviser should check that all necessary permissions were obtained and whether there are any guarantees available.

Bracing between individual trusses appears to be adequate with no movement noted. No cutting out of these timbers should be contemplated without first seeking advice from a Chartered Structural Engineer or a Building Surveyor.

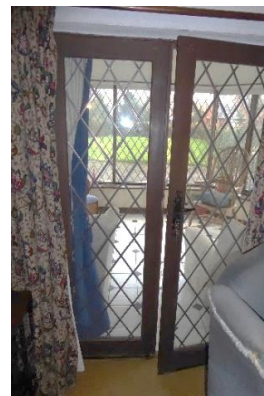
Safety concern – no safety glass

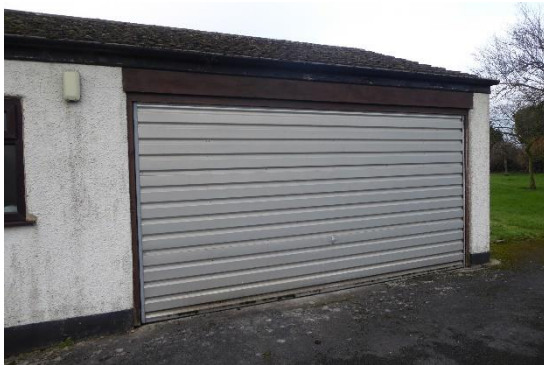
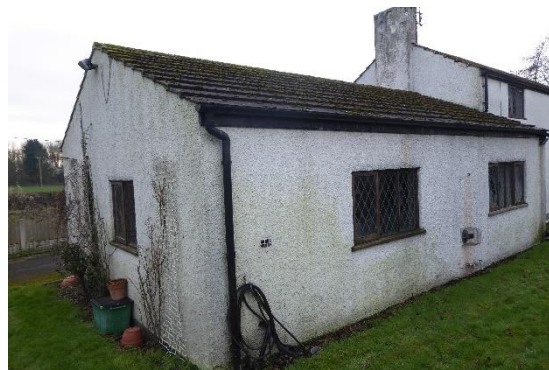
Garage - external

In other respects, the garage is generally in satisfactory condition but there is evidence of normal weathering. You should ensure that the electrics including the mechanically operated door are included as part of any future inspection of the installation. I refer you to my comments in Section F1 in this regard.

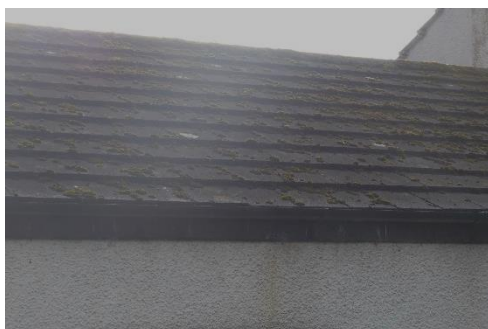
Moss on roof coverings

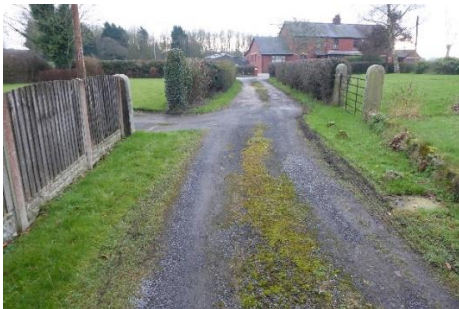
Shared access road

Access is made to the property via a shared access road. You should ask your Legal Adviser to make appropriate enquiries about your rights and responsibilities regarding this including any rights of way which exist.

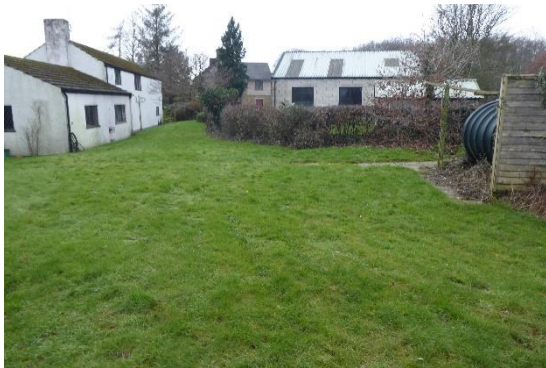
- Some of the timber fencing decayed and repair or replacement is needed.

Condition Rating 2.

Boundary fencing
